Subject: Addendum No. 1
ITB 21-011 – Reynoldsburg Demolition and
Site Work

Asbestos Survey Report

Office Building Property
1418 Brice Road
Reynoldsburg, Franklin County, Ohio

**Reference: Asbestos Survey Report
Office Building Property
1418 Brice Rd., Reynoldsburg, Franklin Co., OH 43068
GCI Project No. 20-E-24278**

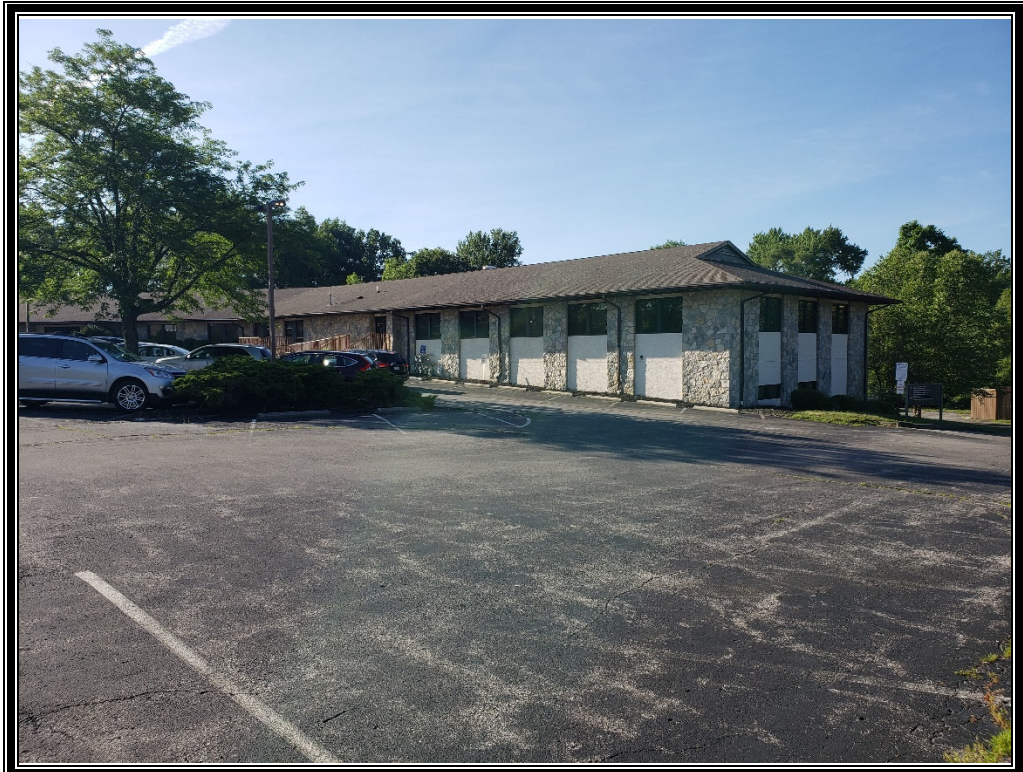
Photo 1: Viewing at the northwest exterior of the office building at 1418 Brice Rd.

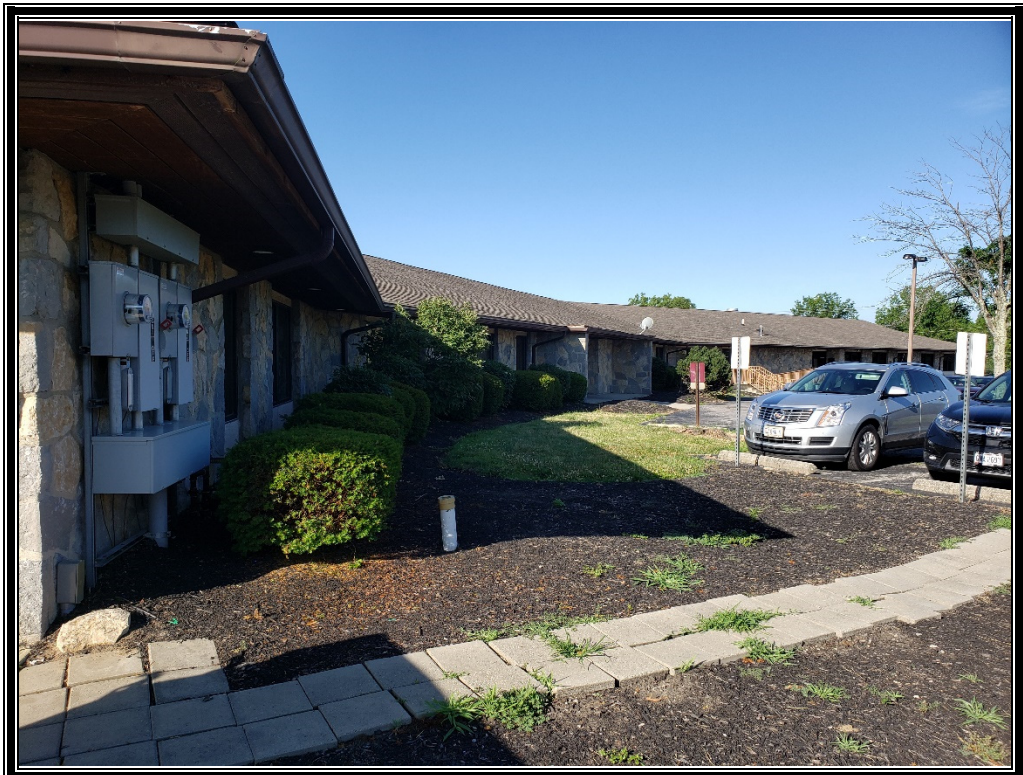
Photo 2: Viewing at the north exterior of the office building.

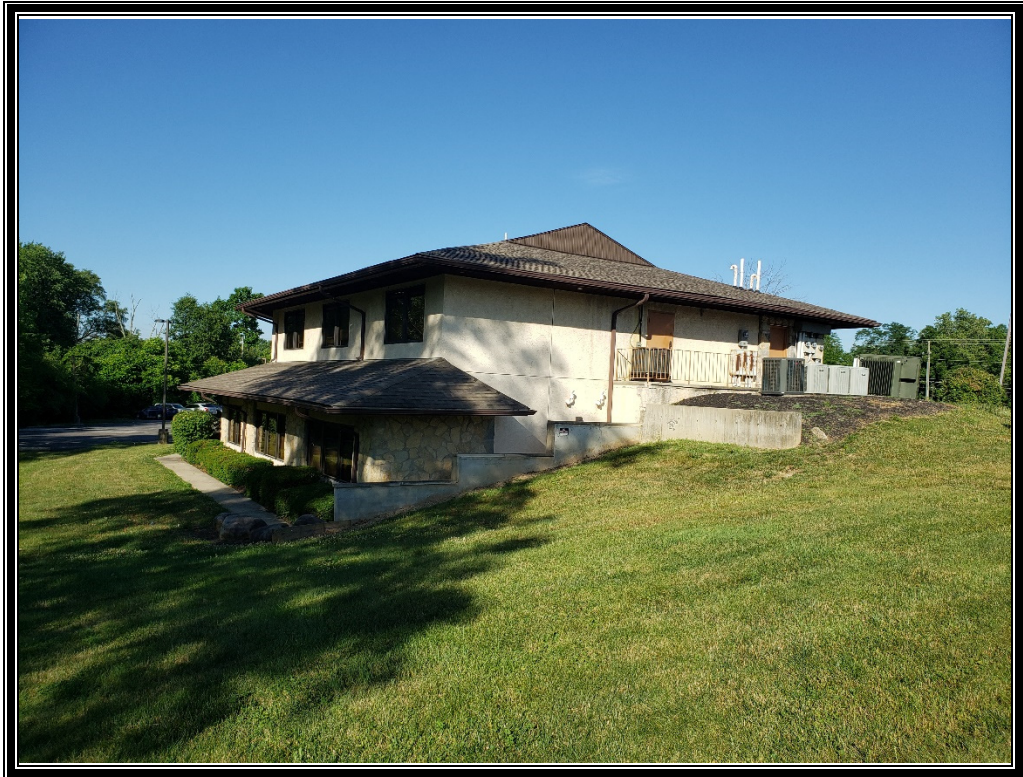
Photo 3: Viewing at the east side of the office building.

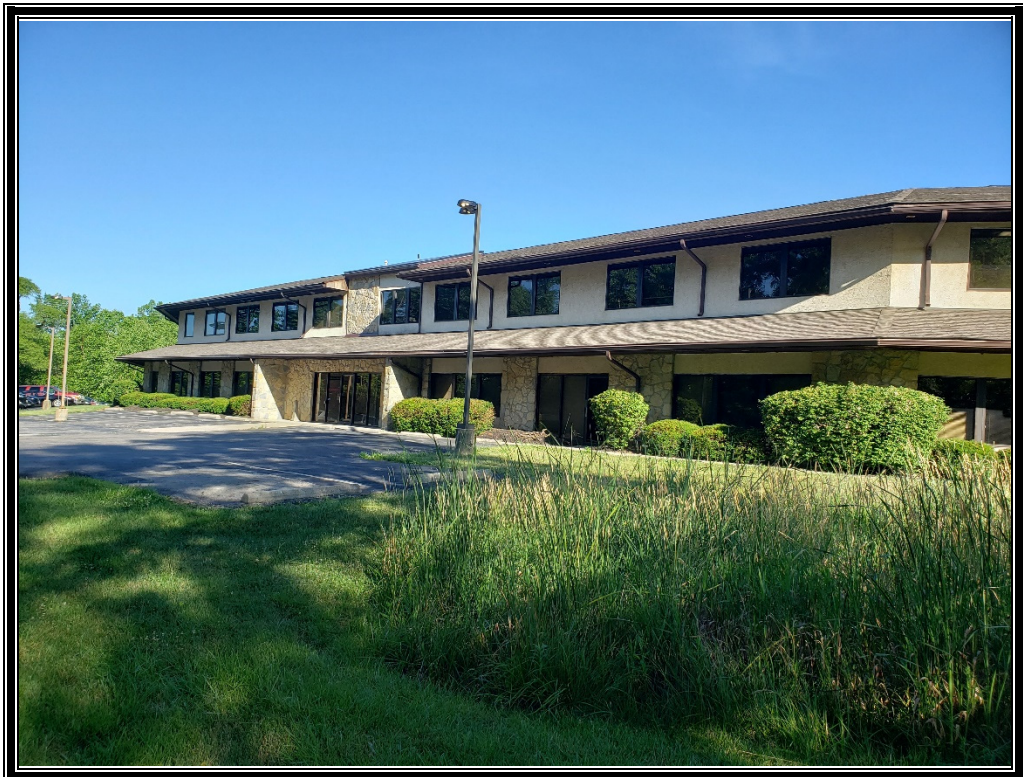
Photo 4: Viewing at the south side of the office building.

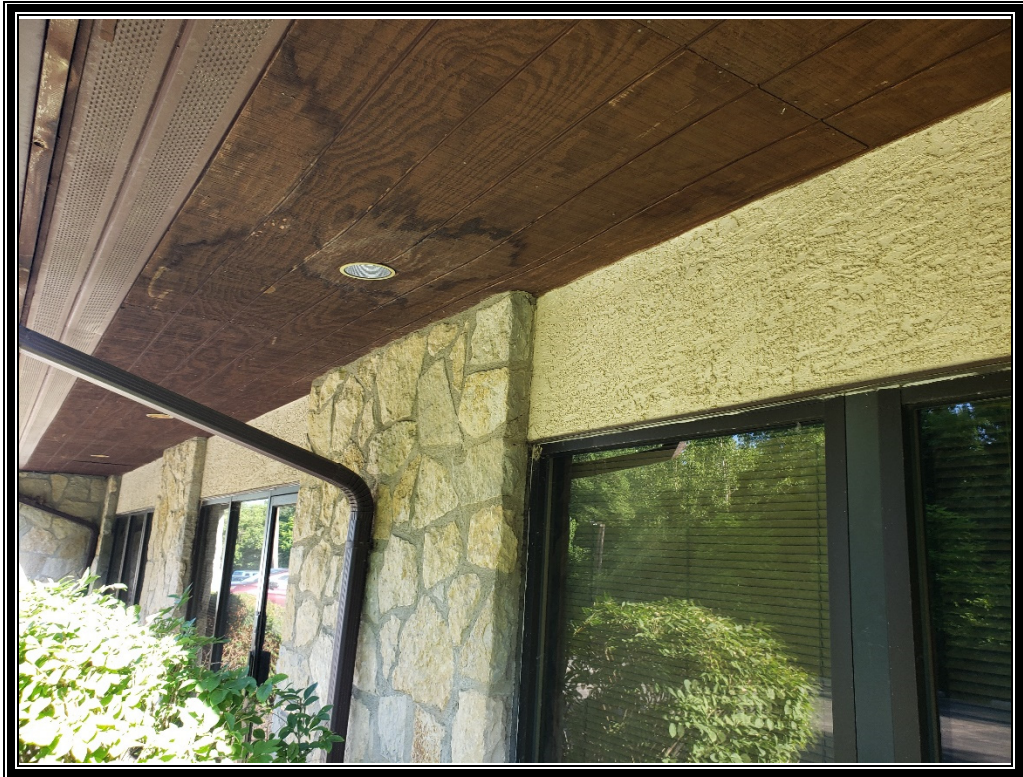
Photo 5: Viewing at the office building exterior materials including stucco, stone, window caulk, and wood trim.

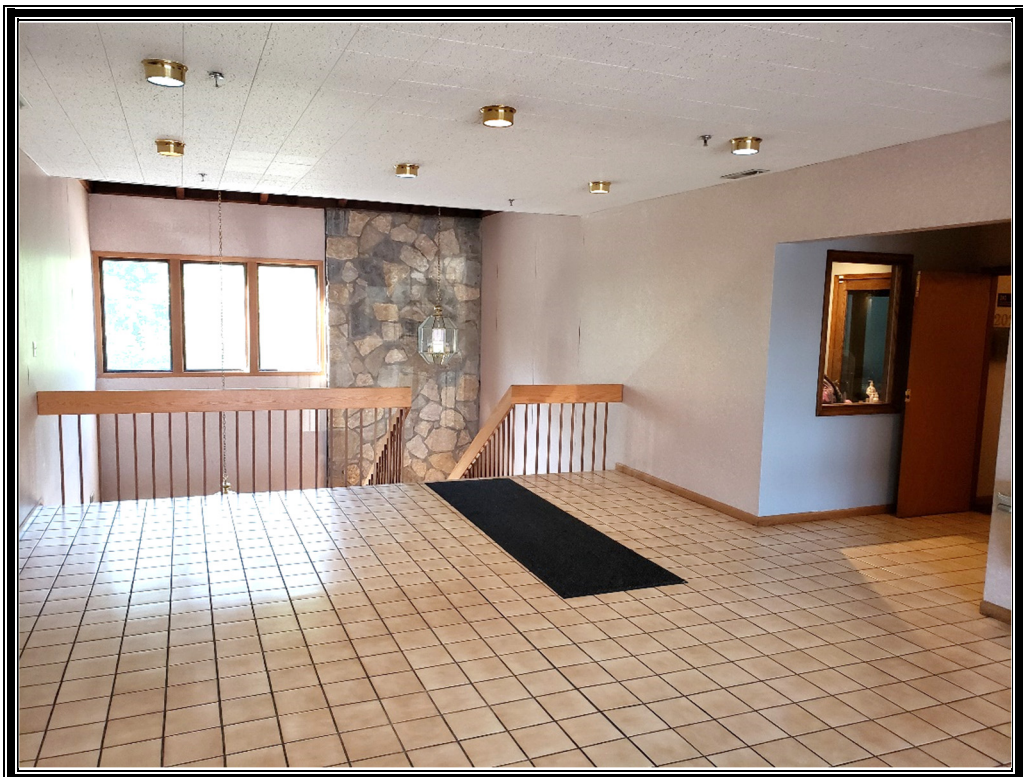
Photo 6: Viewing at the upper level east lobby in the office building.

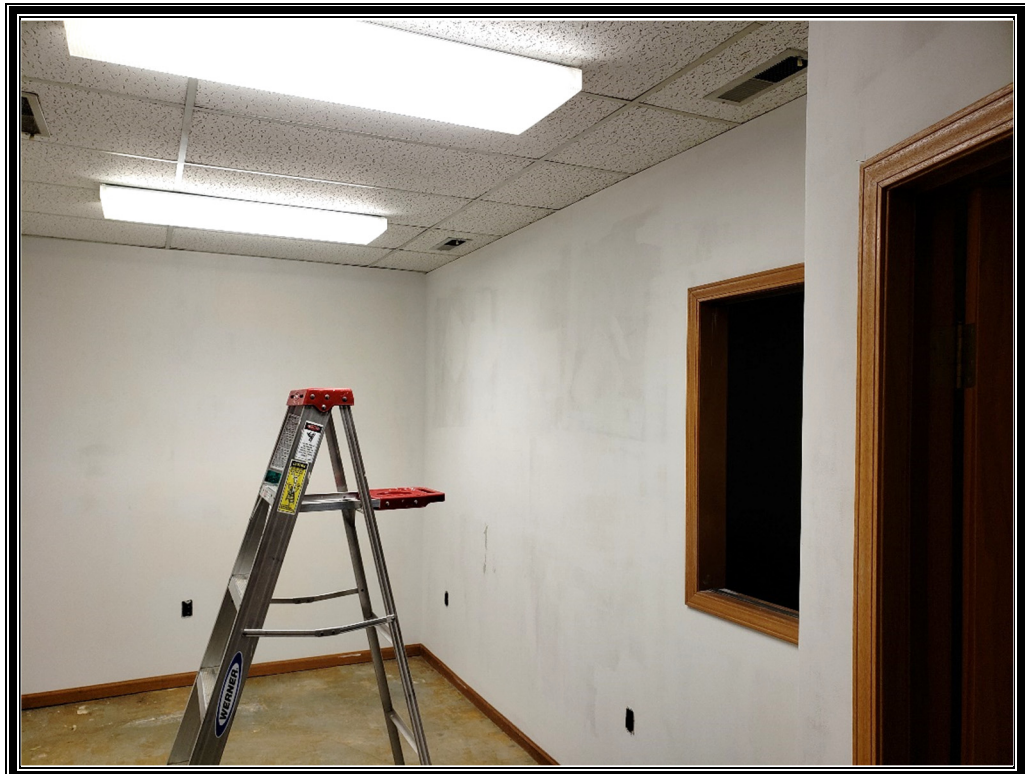
Photo 7: Viewing at acoustical ceiling panels, drywall, and exposed carpet mastic in Unit 201.

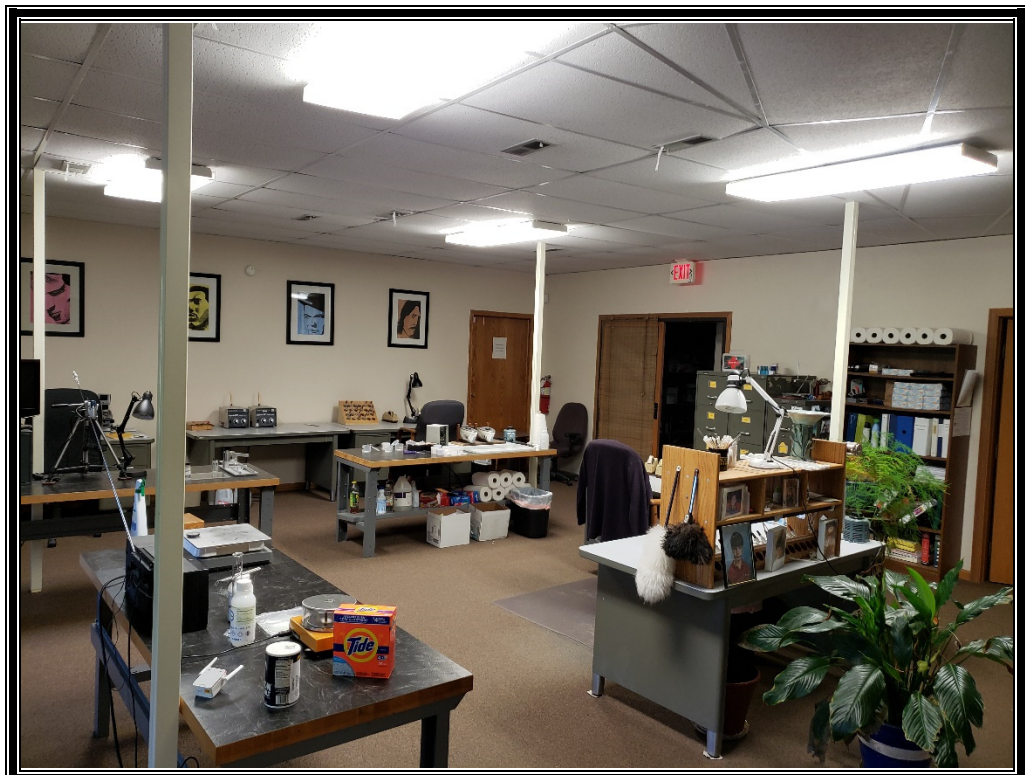
Photo 8: Viewing at the Evolutions unit with acoustical ceiling panels, drywall, and carpet.

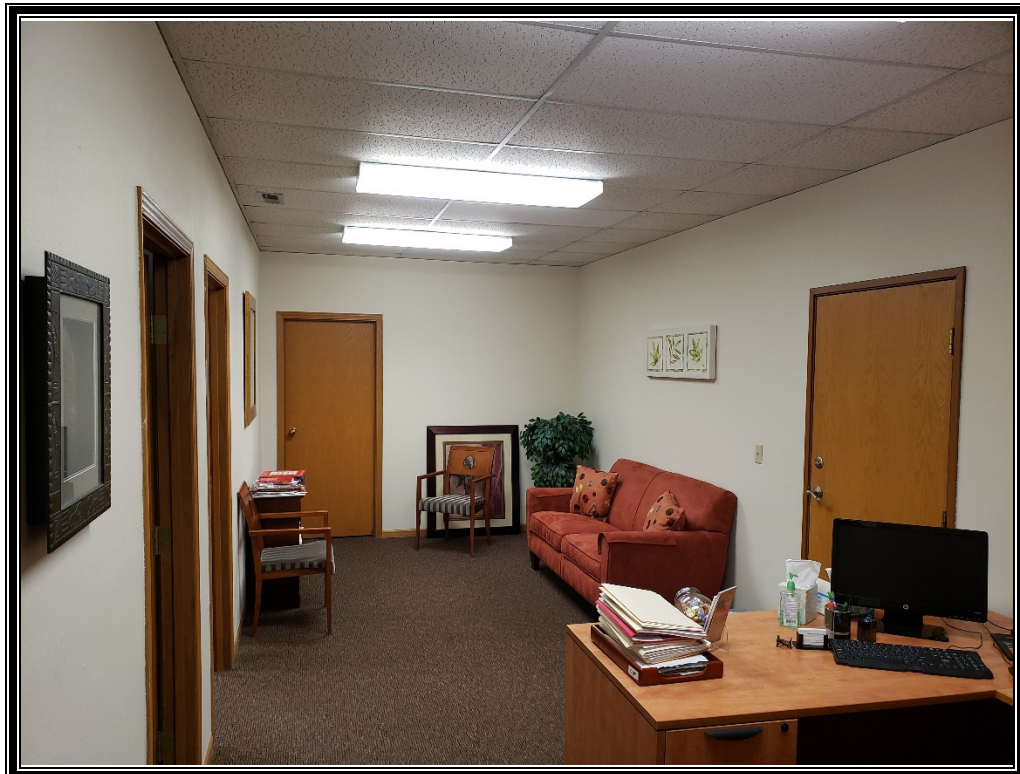
Photo 9: Viewing at the lobby in the Marshall Financial Group unit with acoustical ceiling panels, drywall, and carpet..

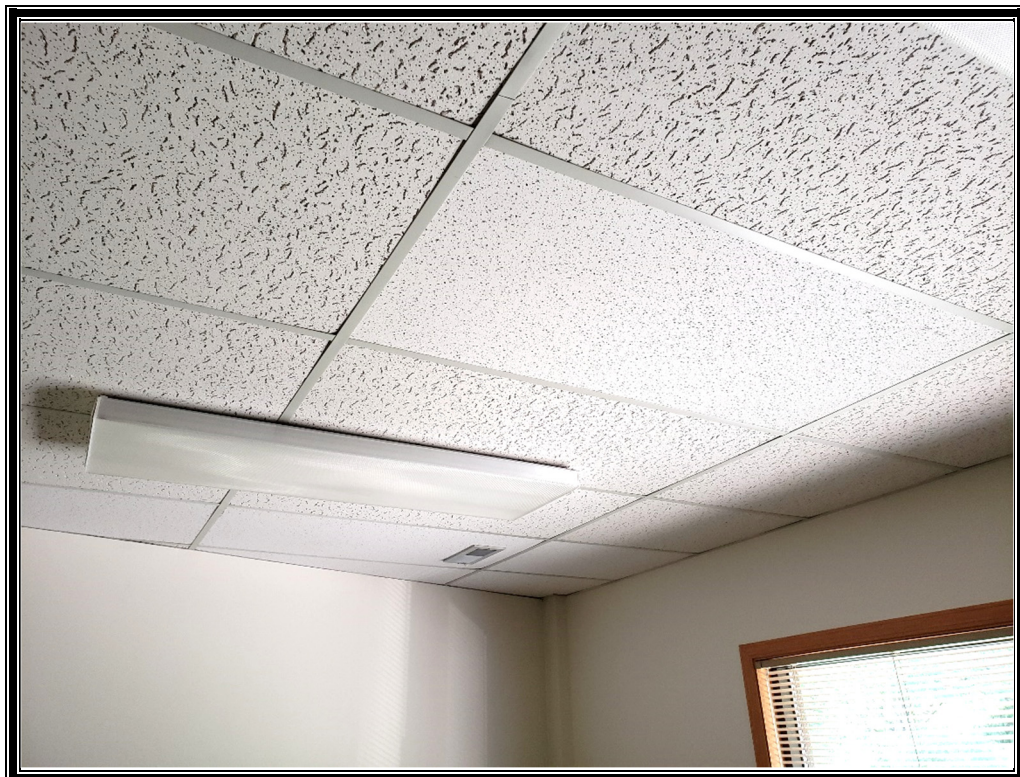
Photo 10: Viewing at two styles of acoustical ceiling panels in the Marshall Financial Group unit.

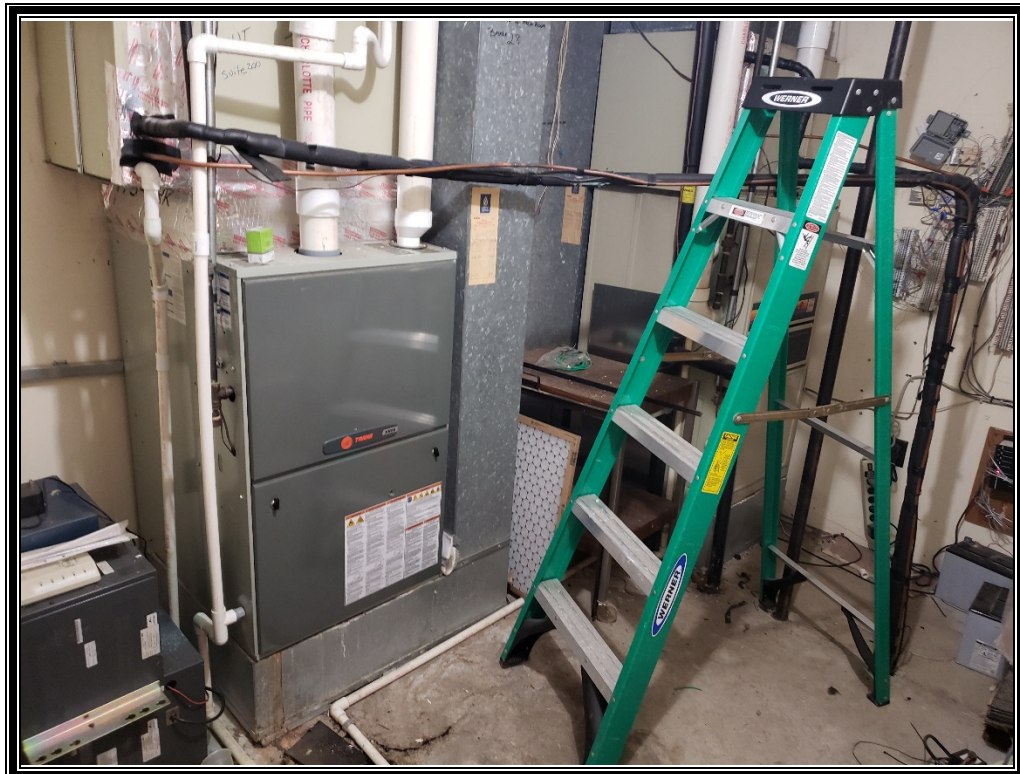
Photo 11: Viewing at one of the natural gas forced air furnaces in the building.

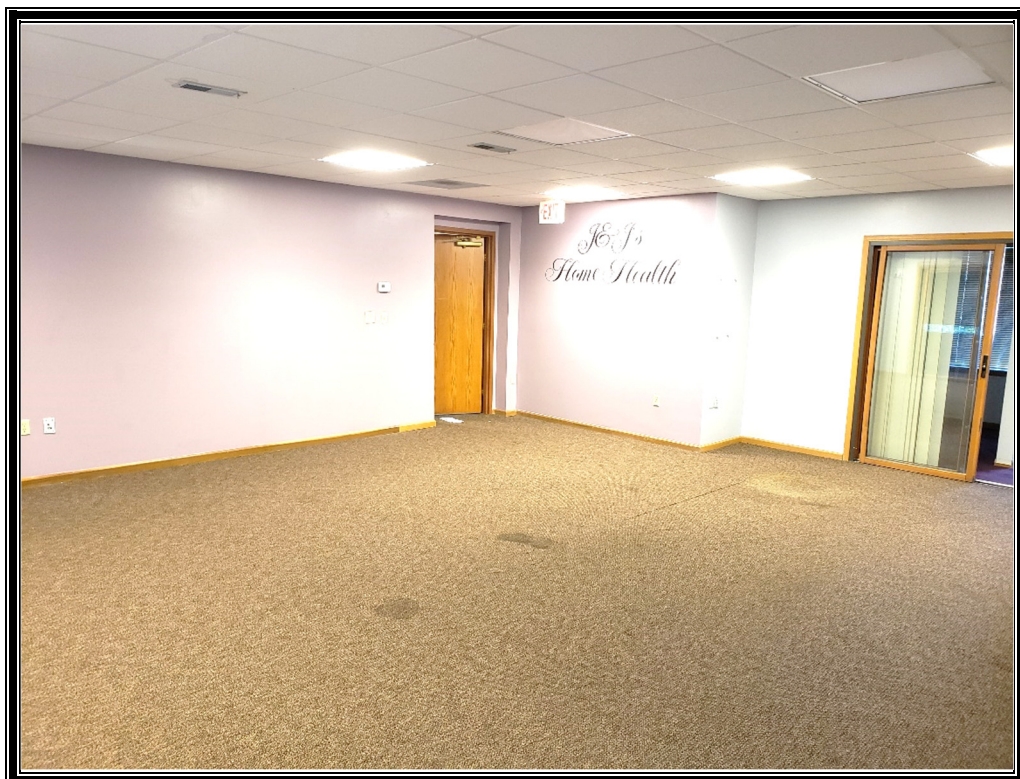
Photo 12: Viewing at the vacated J&J's Home Health unit with acoustical ceiling panels, drywall, and carpet.

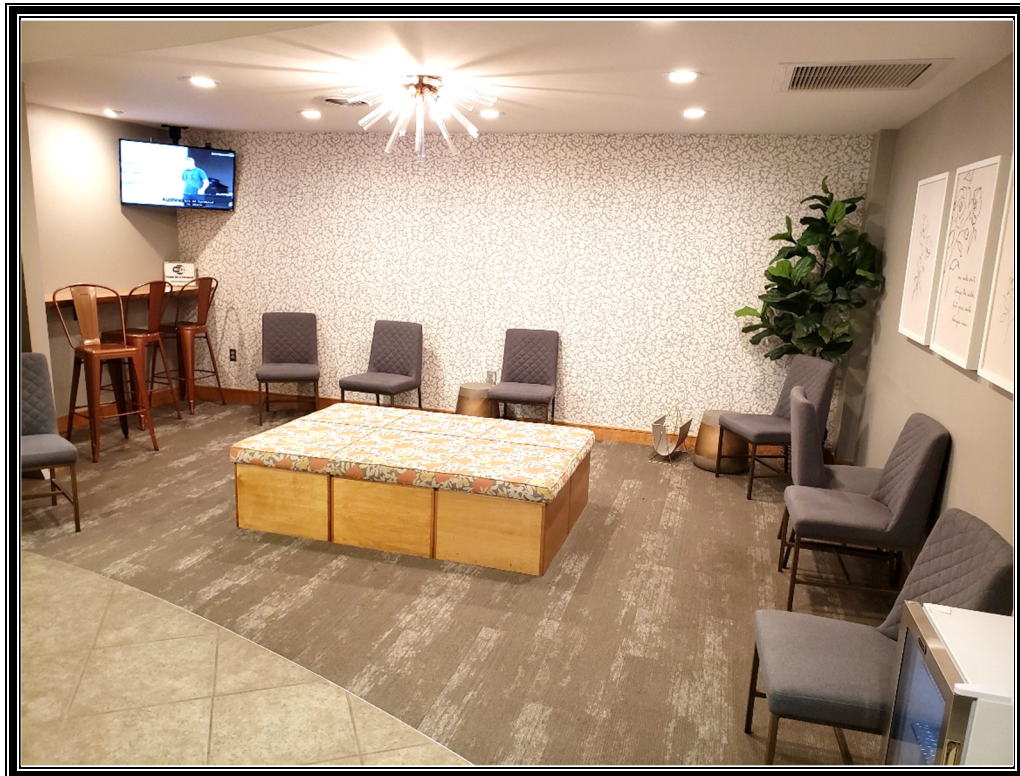
Photo 13: Viewing at the lobby in the Hickman Orthodontist unit.

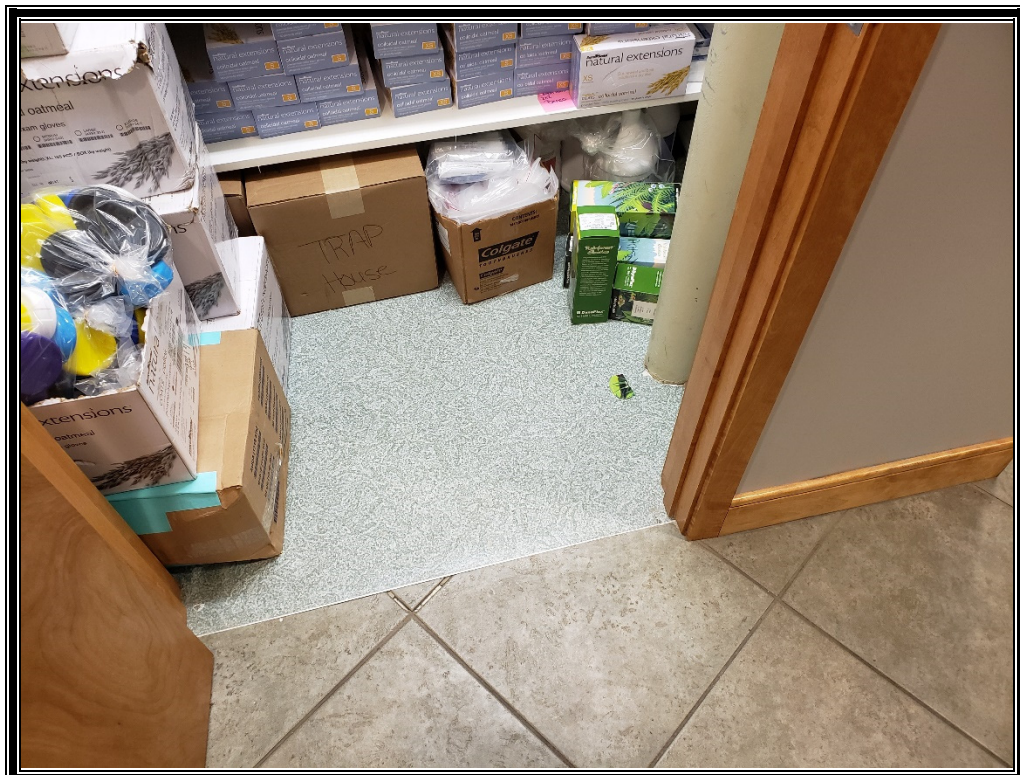
Photo 14: Viewing at sheet vinyl flooring in a closet of the Hickman Orthodontist unit.

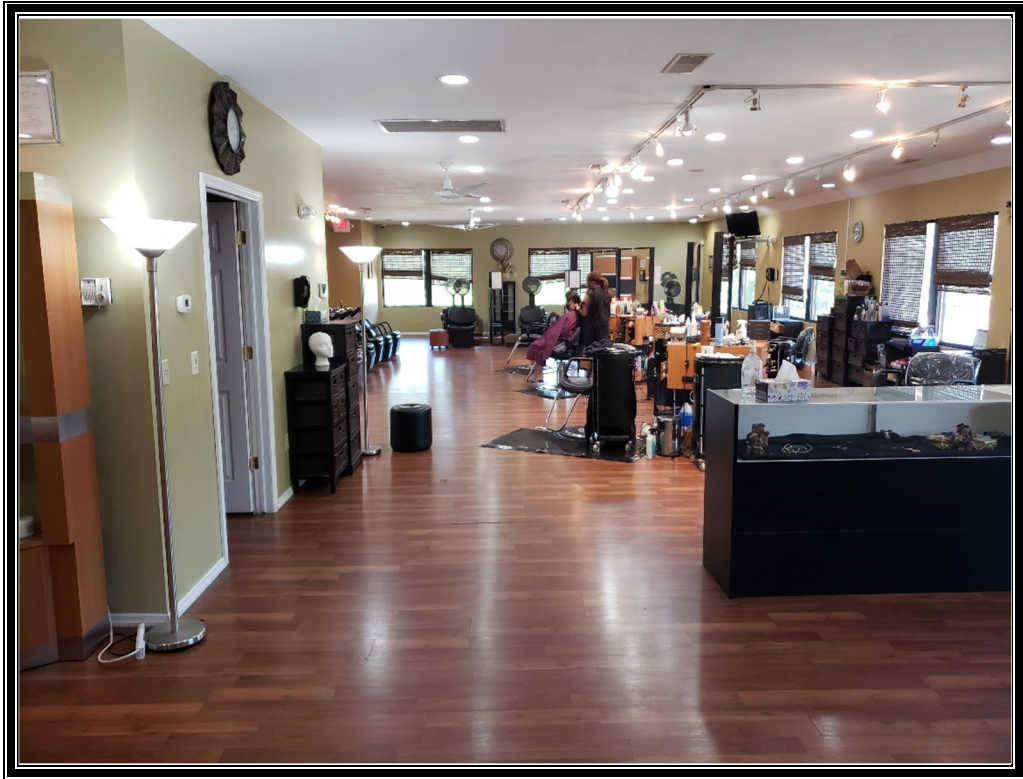
Photo 15: Viewing at the Artistic Ebony Salon with drywall and wood flooring.
