Mays Consulting & Evaluation Services, Inc.

A Professional Consulting & Engineering Organization

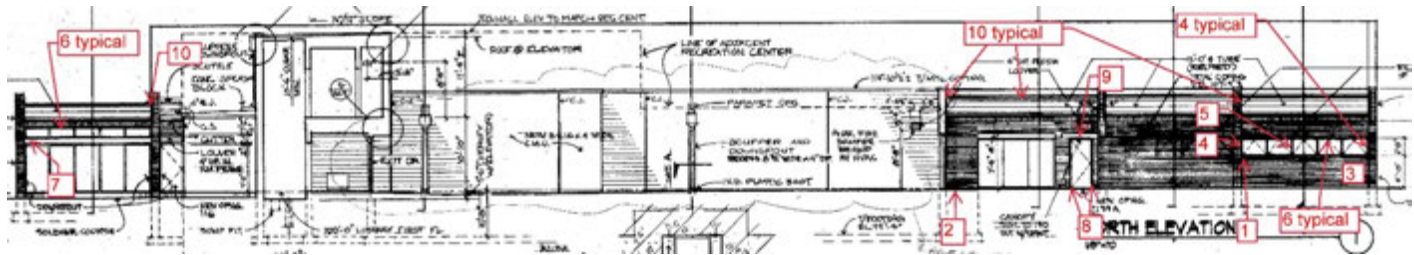
Walls Windows and Doors - North Elevation

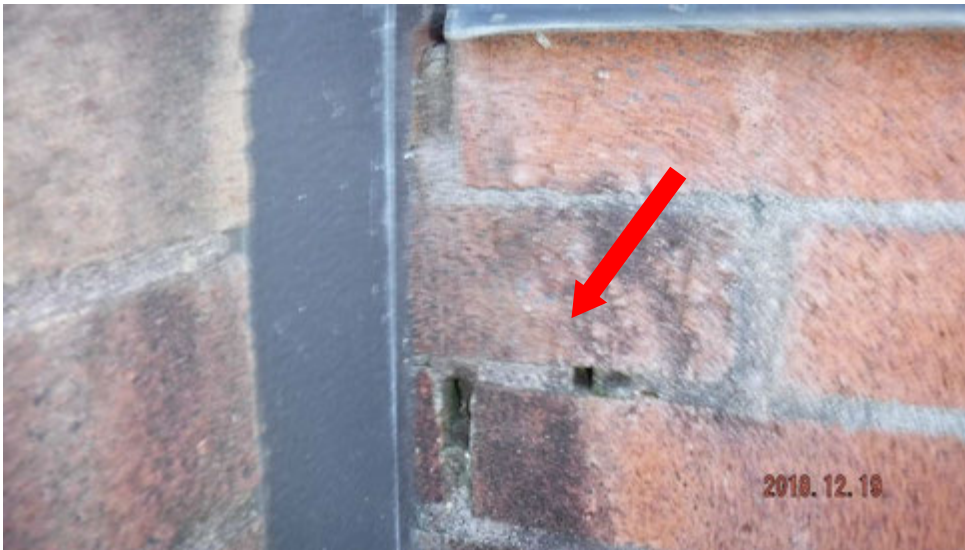
1a. Deteriorated mortar joints (see #1 on elevation photo for location).

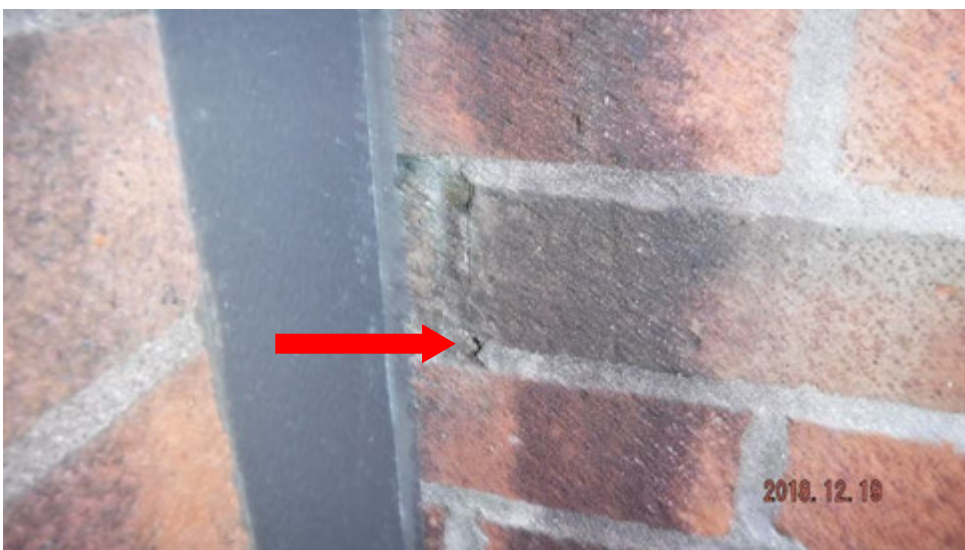
1b. Deteriorated mortar joints (see #1 on elevation photo for location).

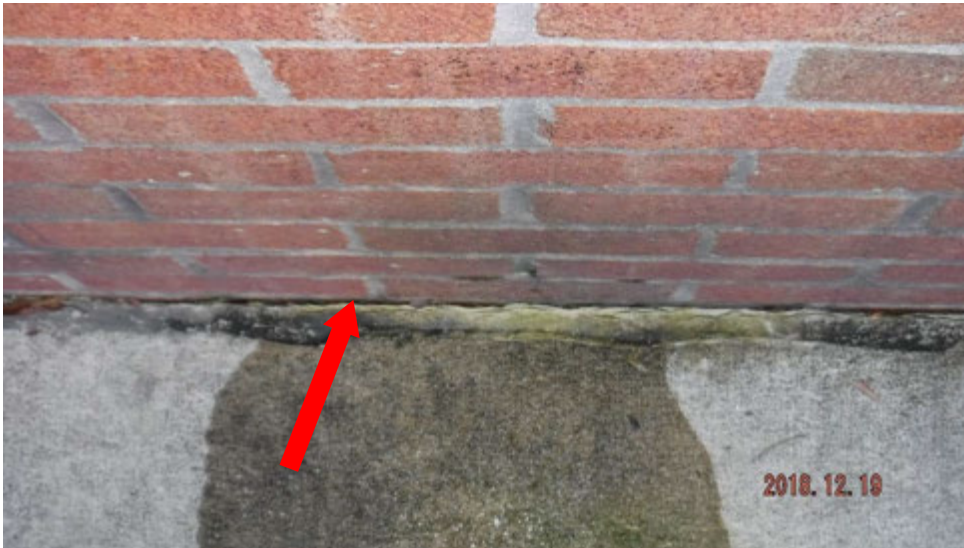
2a. Cracked/shrunk sealant joint between masonry wall and concrete sidewalk (see #2 on elevation photo for location).

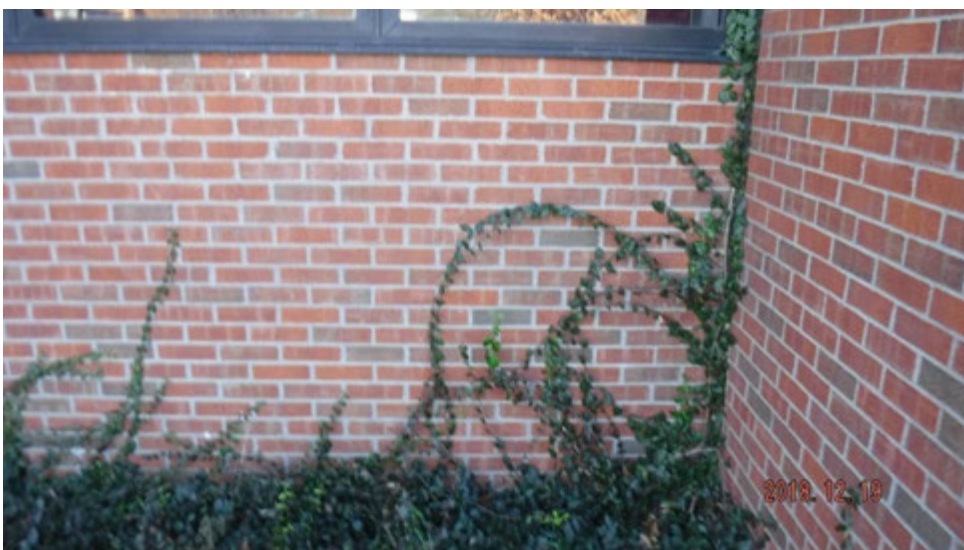
3a. Vegetation growth on walls (see #3 on elevation photo for typical location).

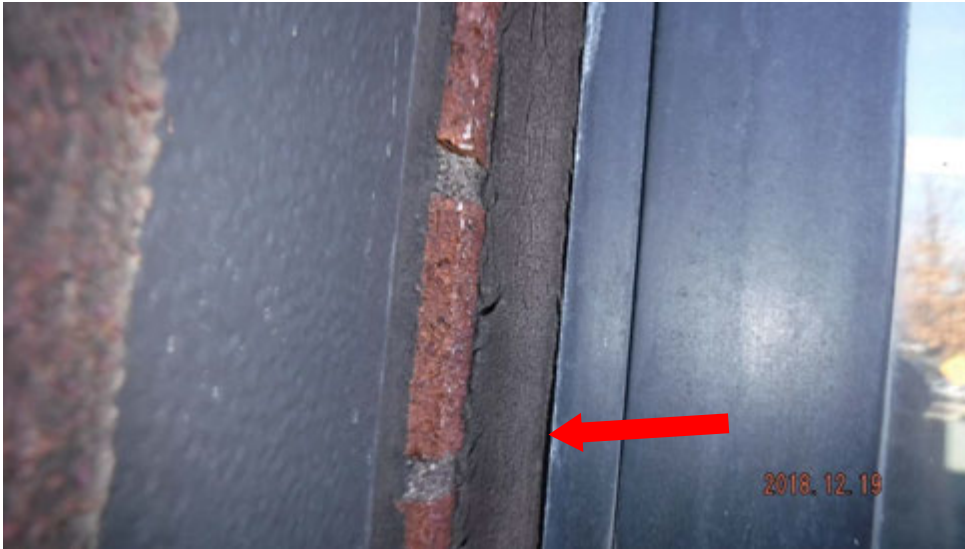
4a. Cracked/shrunk sealant joint (see #4 on elevation photo for typical locations).

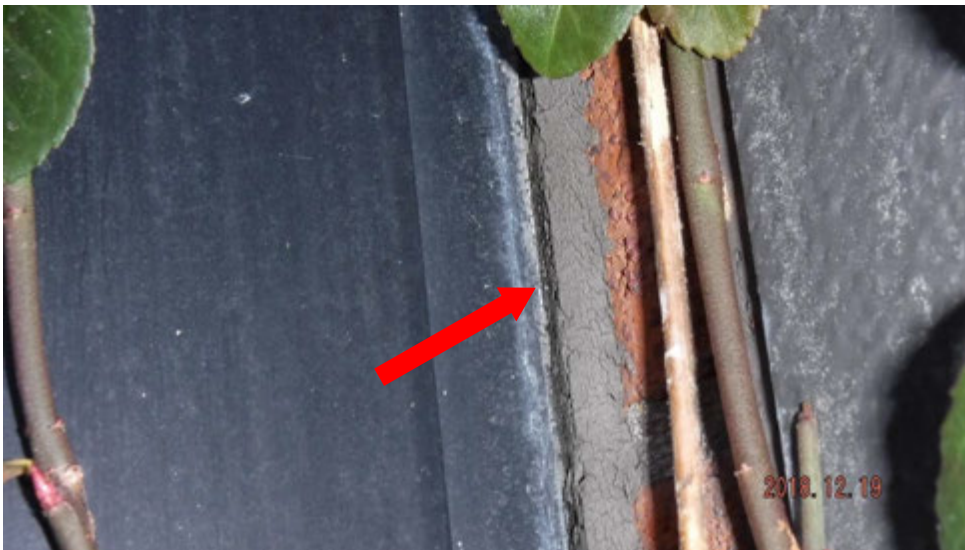
4b. Cracked/shrunk sealant joint (see #4 on elevation photo for typical locations).

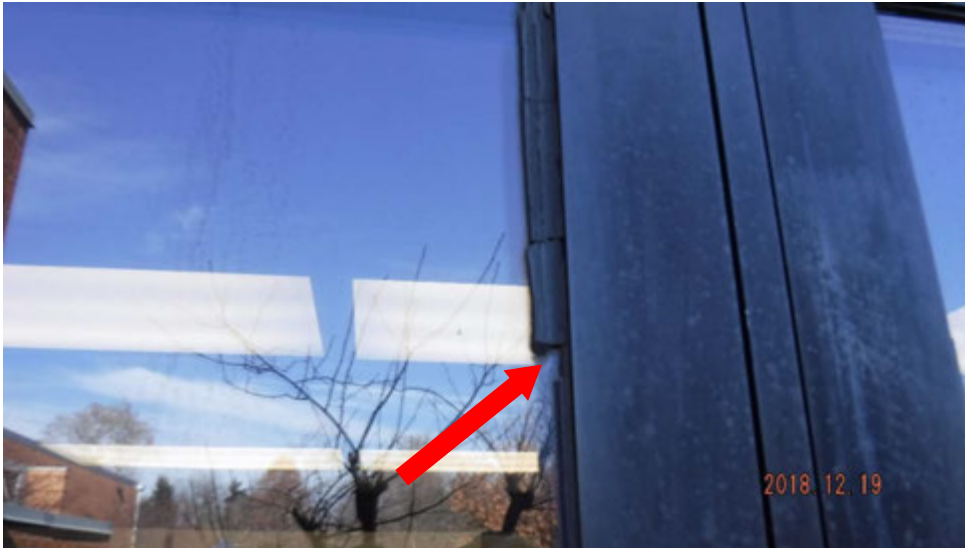
5a. Deteriorated and/or missing sealant between window glass and frame (see #5 on elevation photo for location).

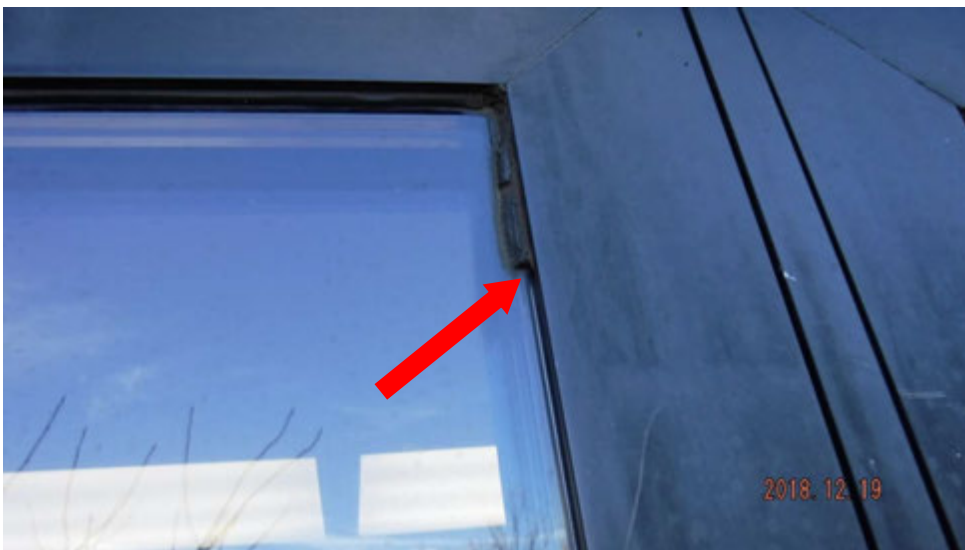
5b. Deteriorated and/or missing sealant between window glass and frame (see #5 on elevation photo for location).

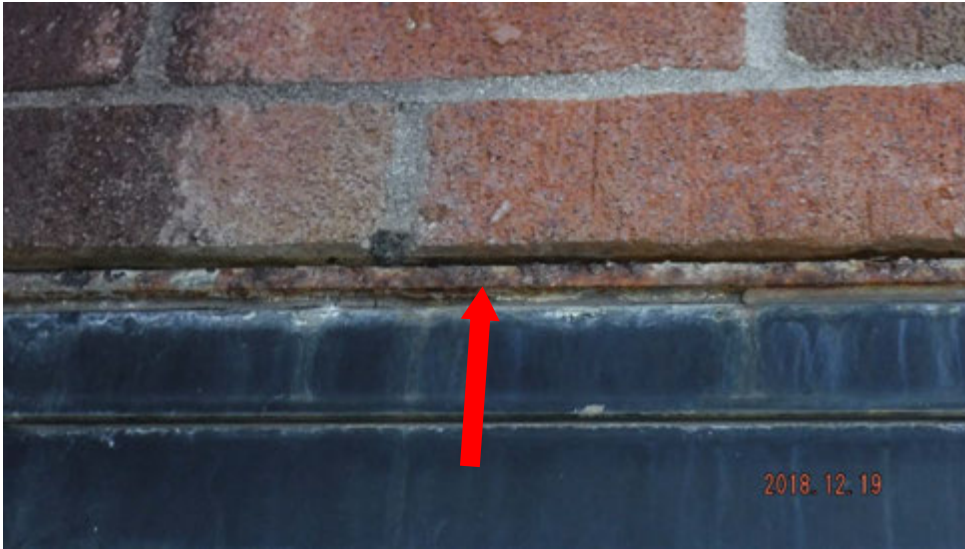
6a. Corrosion on window lintel (see #6 on elevation photo for typical locations).

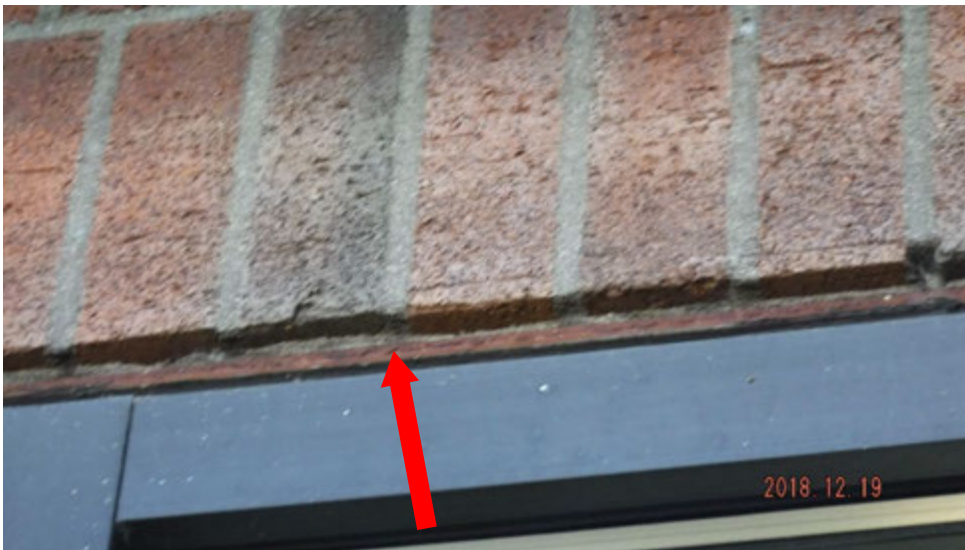
6b. Corrosion on window lintel (see #6 on elevation photo for typical locations).

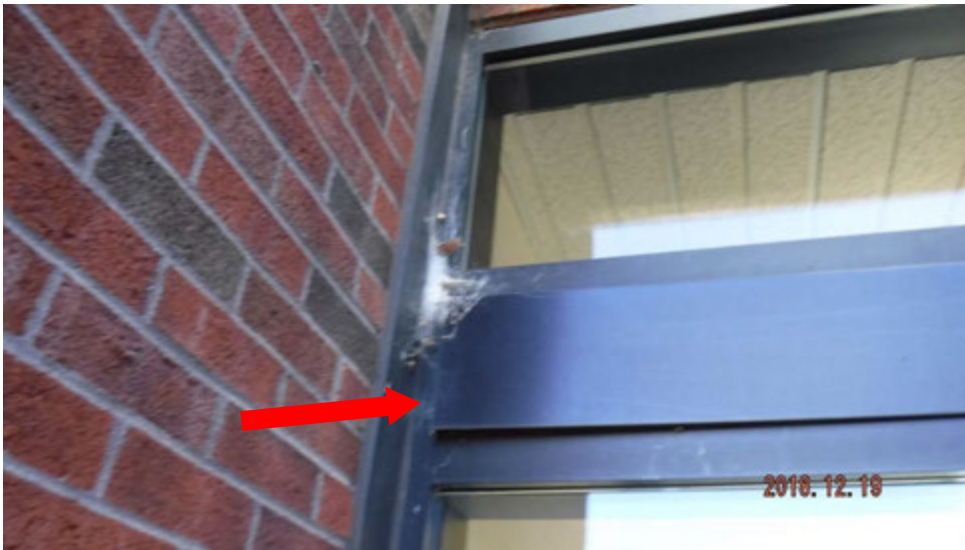
7a. Loose window trim metal between window sets (see #7 on elevation photo for location).

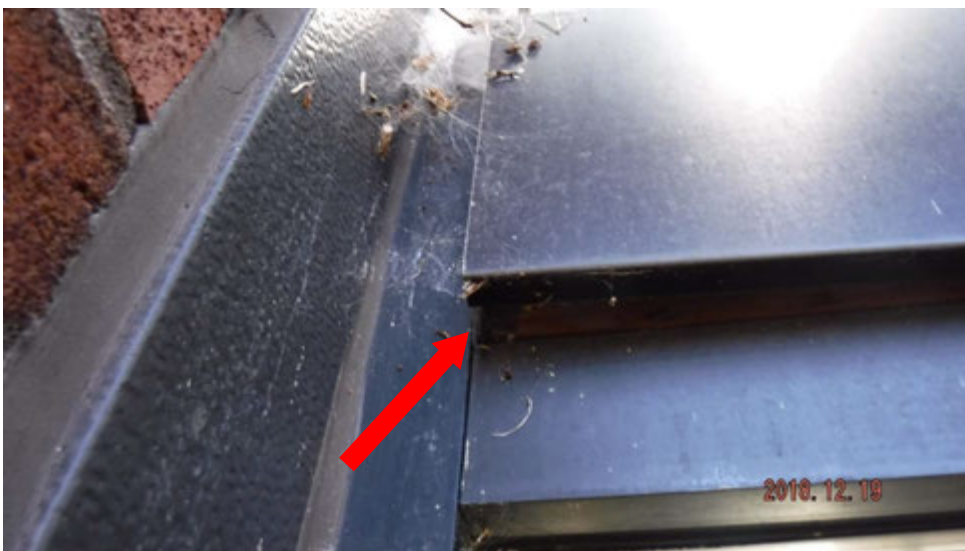
7b. Loose window trim metal between window sets. Wood could be observed behind the loose metal (see #7 on elevation photo for location).

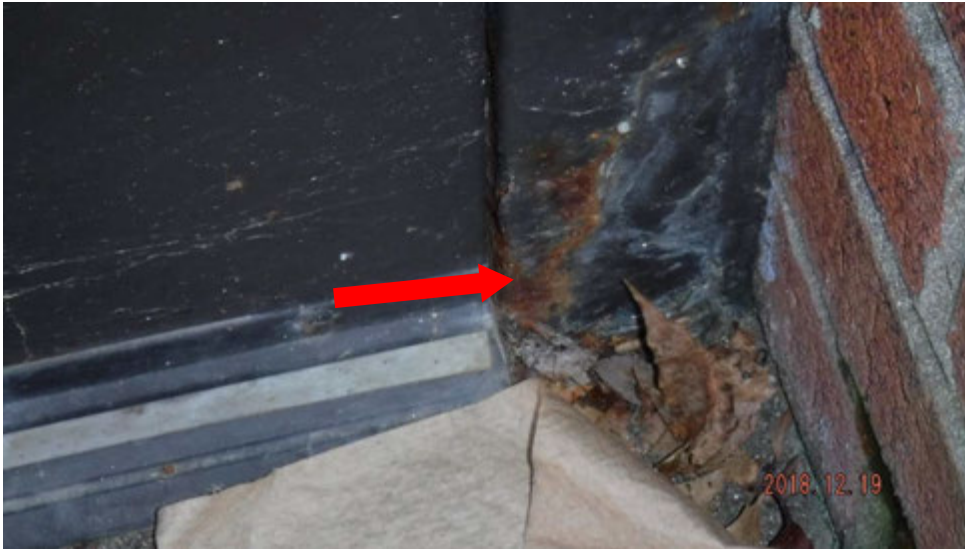
8a. Corrosion at door frame (see #8 on elevation photo for location).

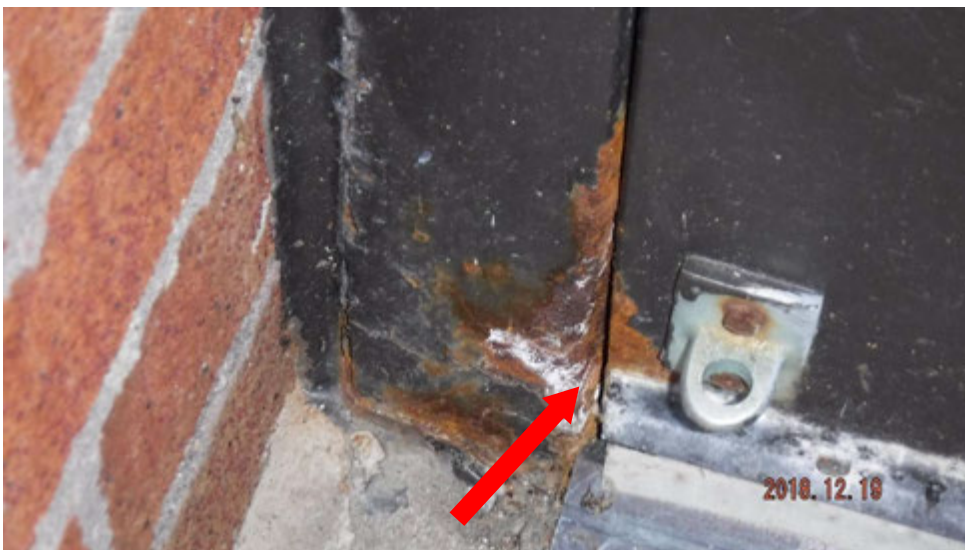
8b. Corrosion at door and door frame (see #8 on elevation photo for location).

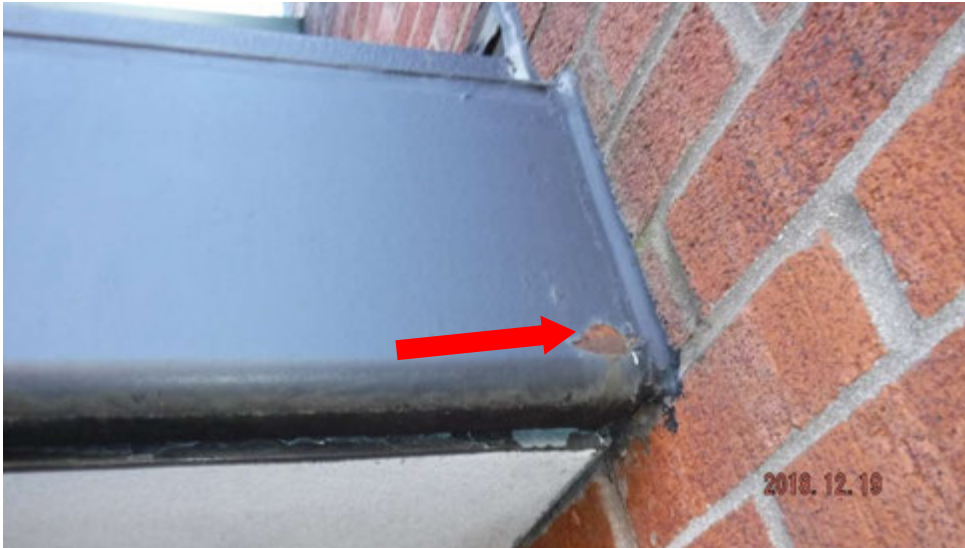
9a. Corrosion at canopy fascia (see #9 on elevation photo for location).

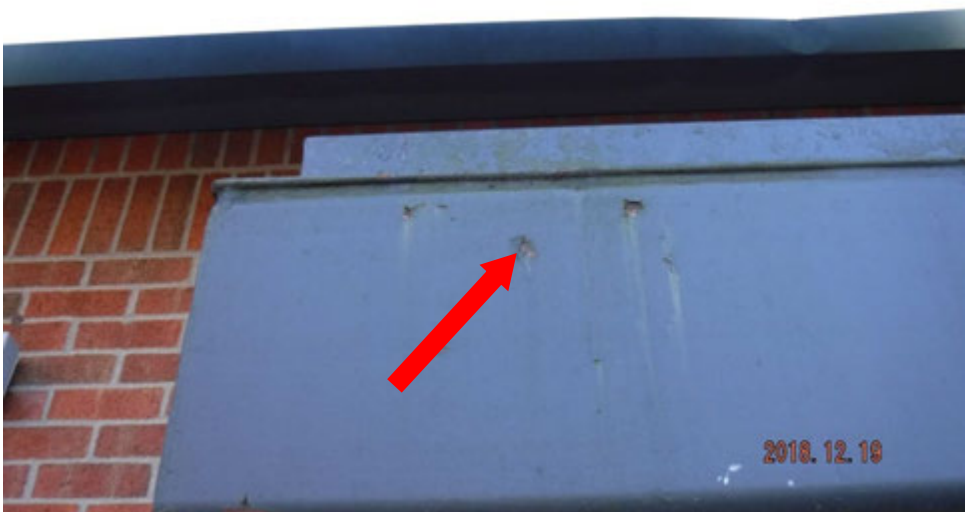
9b. Corrosion at canopy fascia (see #9 on elevation photo for location).

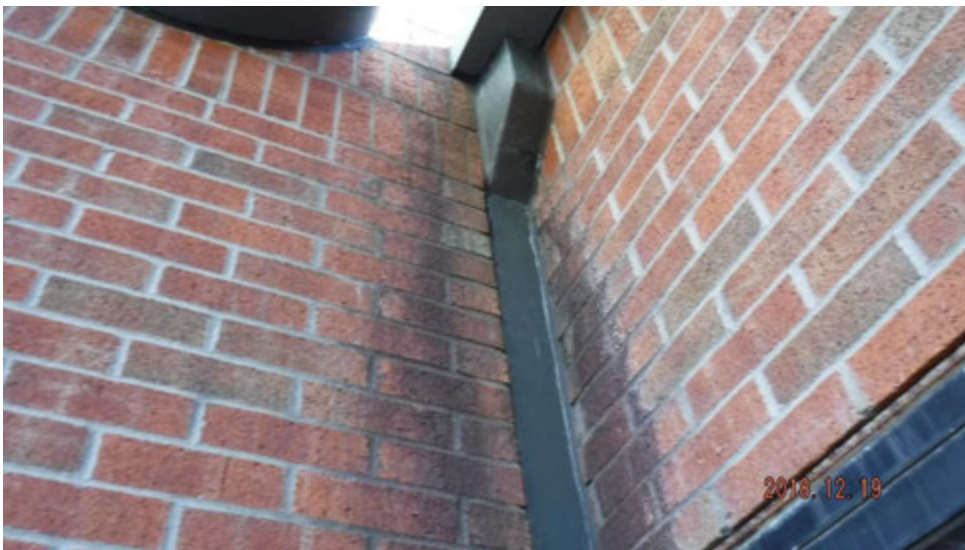
10a. Staining of masonry due to gutter and/or downspout leaks (see #10 on elevation photo for typical locations).

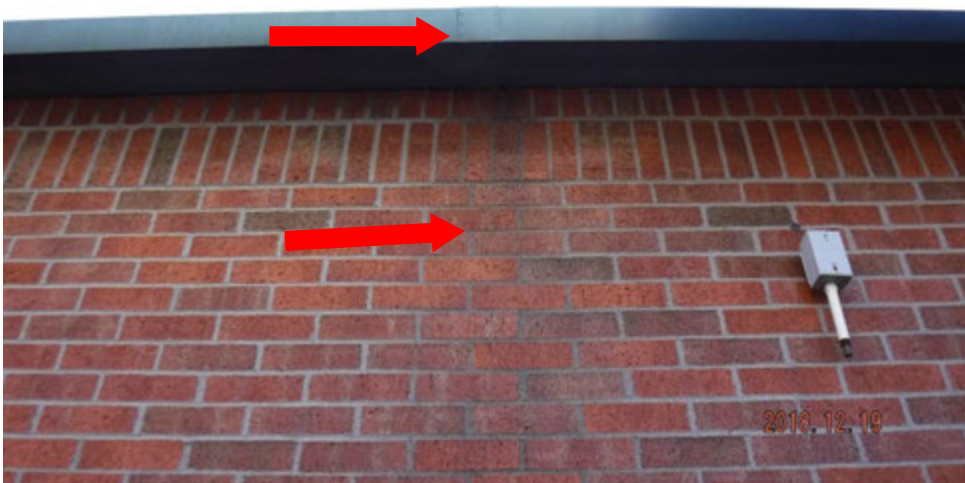
10b. Leaking gutter joint causing staining on masonry (see #10 on elevation photo for typical locations).

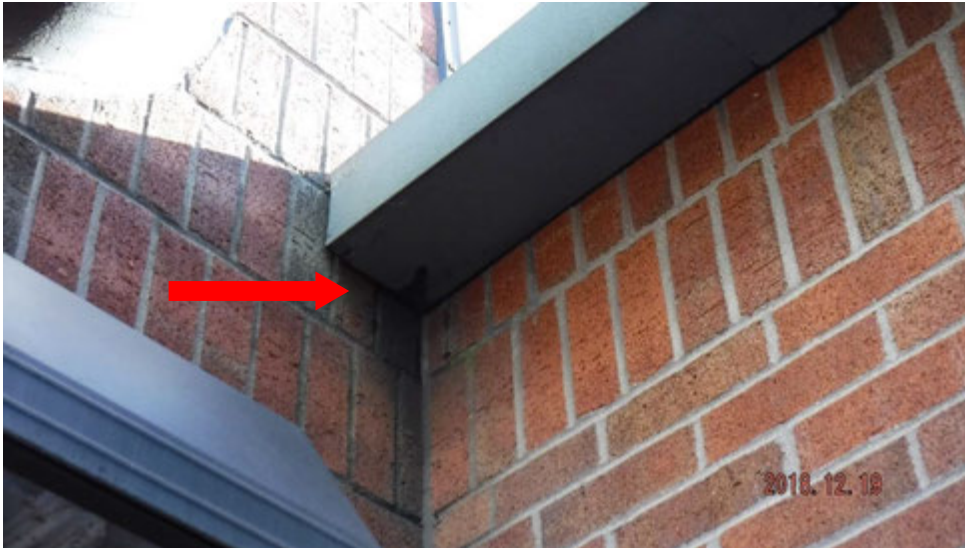
10c. Leaking gutter end cap (see #10 on elevation photo for typical locations).

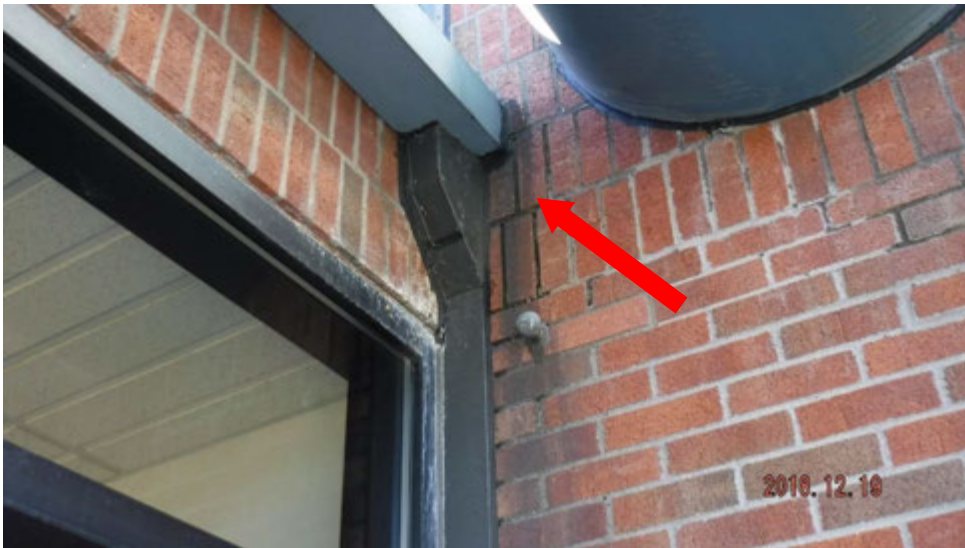
10d. Leaking gutter end cap and/or connection to downspout (see #10 on elevation photo for typical locations).

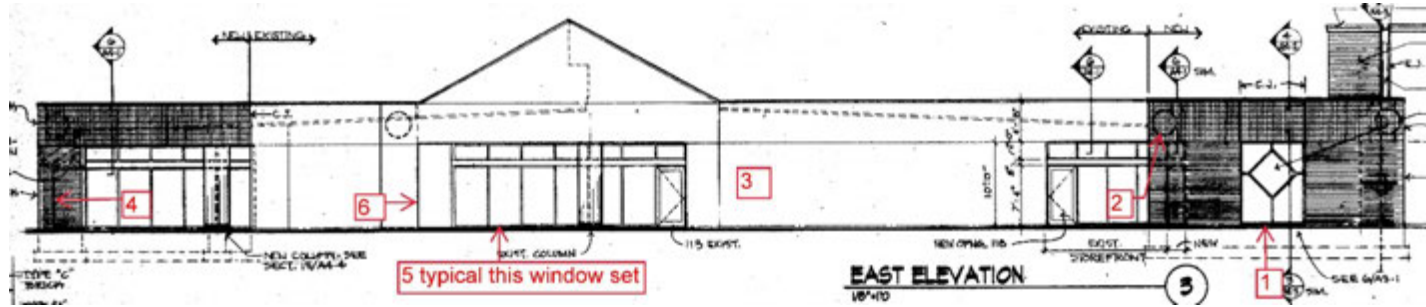
Walls Windows and Doors - East Elevation

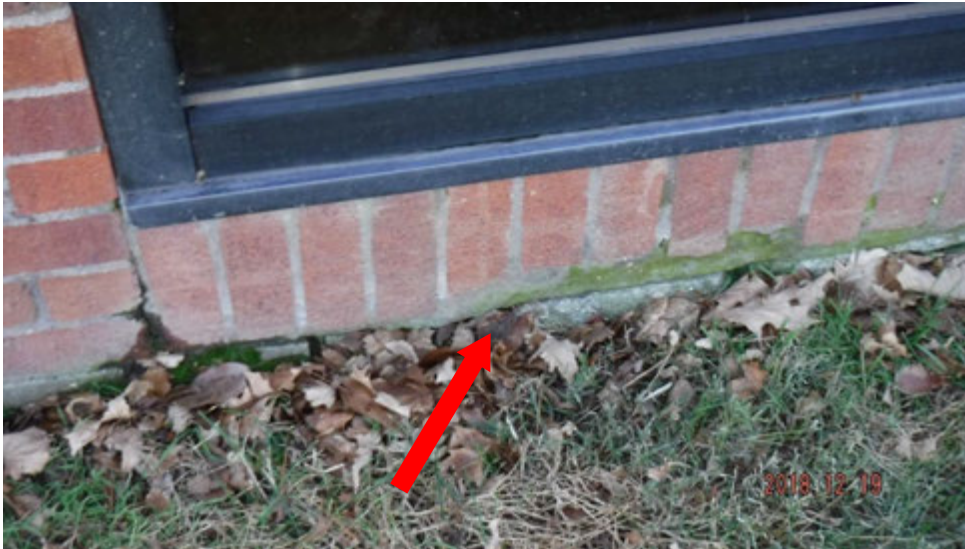
1a. Poor/deficient foundation below window (see #1 on elevation photo for location).

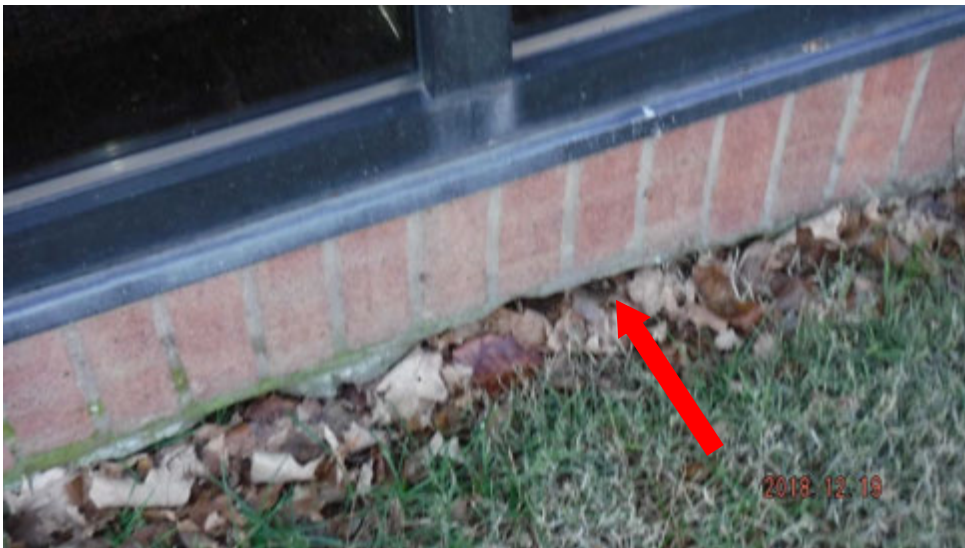
1b. Poor/deficient foundation below window (see #1 on elevation photo for location).

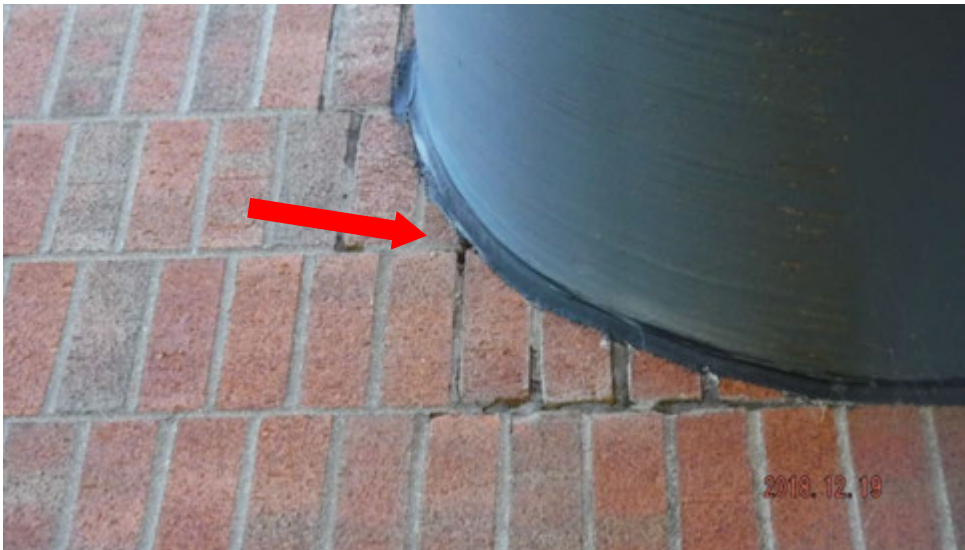
2a. Deteriorated mortar joints (see #2 on elevation photo for location).

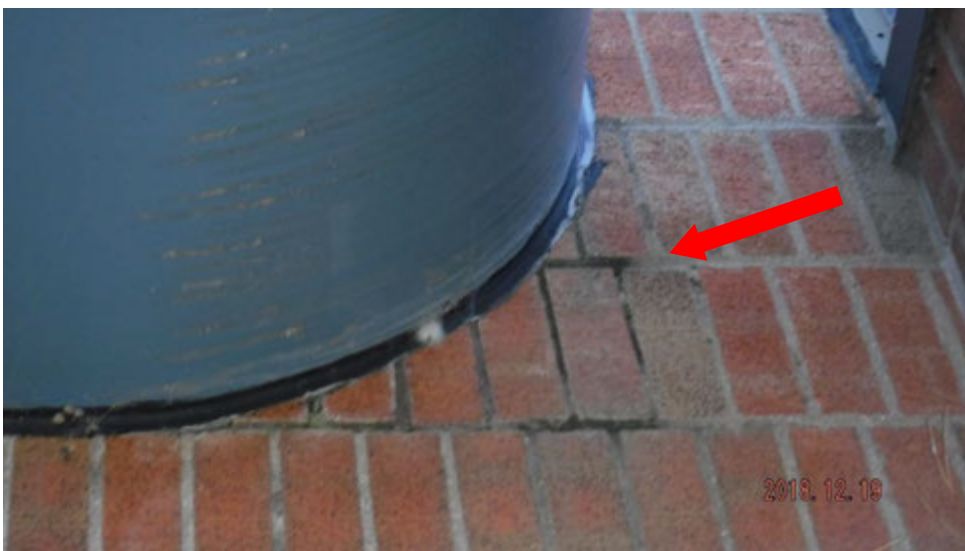
2b. Masonry appears to be holding moisture and not drying out as needed (see #2 on elevation photo for location).

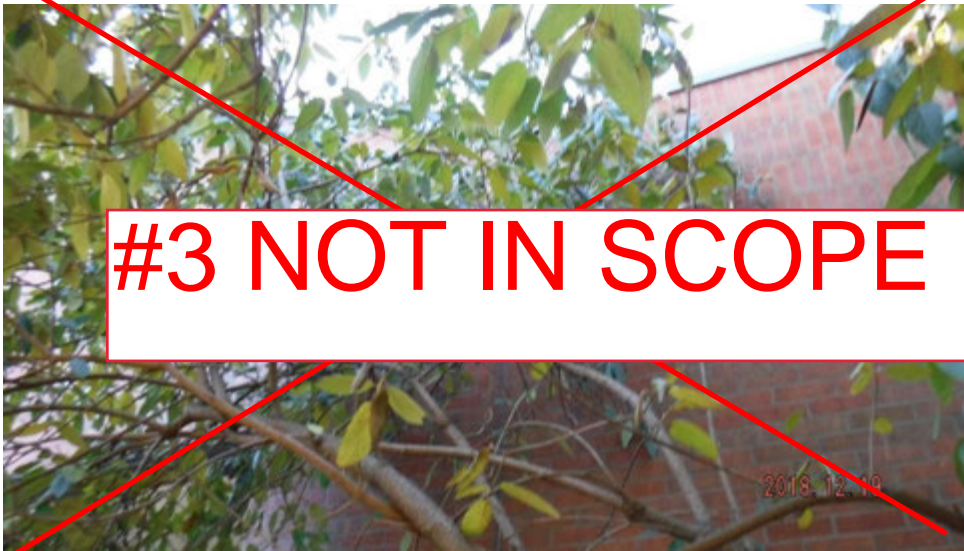
3a. Tree branches growing into masonry walls (see #3 on elevation photo for location).

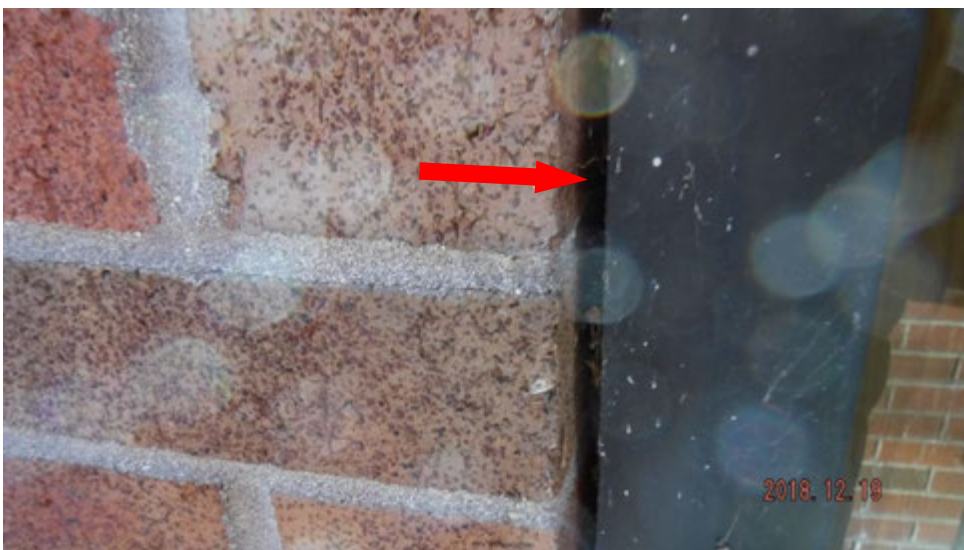
4a. Open joint between masonry wall and window frame (see #4 on elevation photo for location).

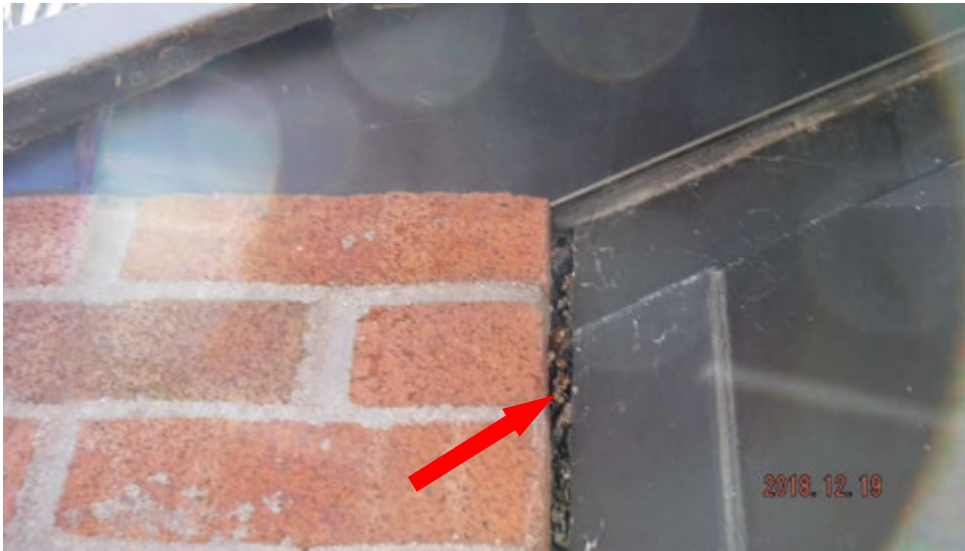
4b. Open joint between masonry wall and window frame (see #4 on elevation photo for location).

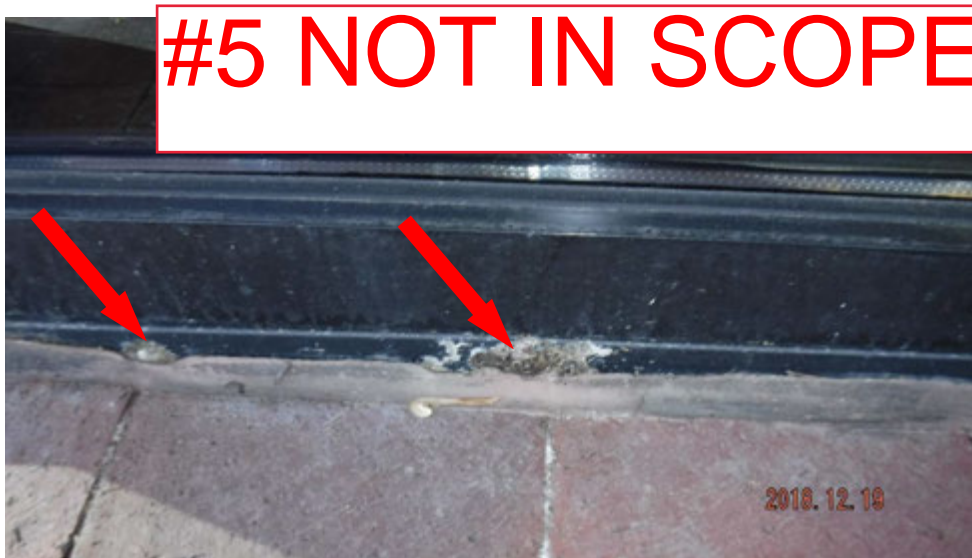
5a. Corroded steel member(s) at base of window where it sets at ground level (see #5 on elevation photo for location).

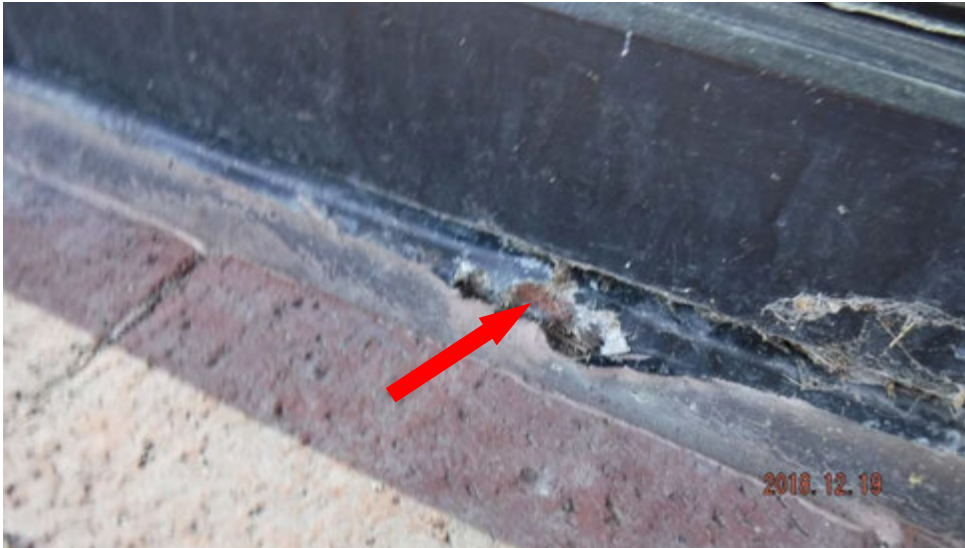
5b. Corroded steel member(s) at base of window where it sets at ground level (see #5 on elevation photo for location).

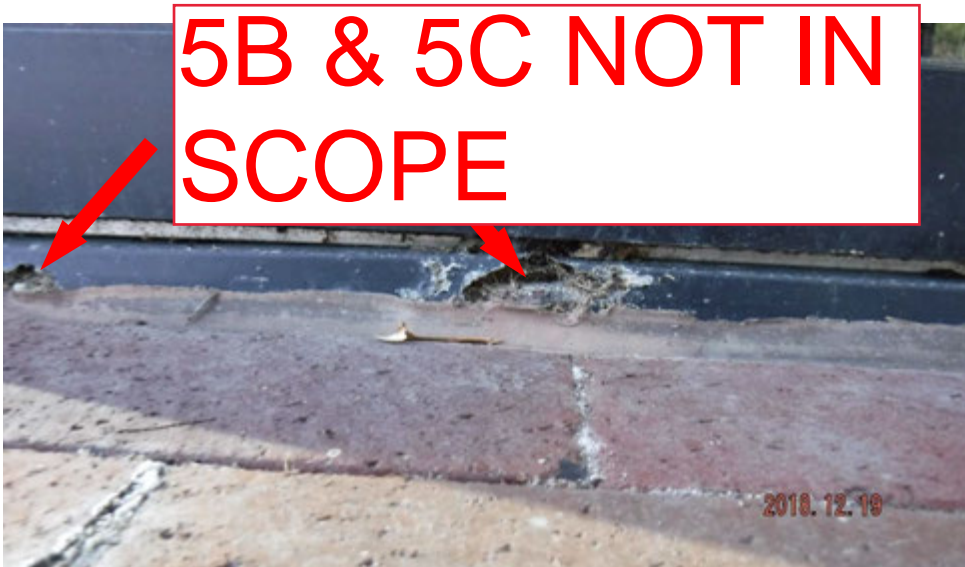
5c. Corroded steel member(s) at base of window where it sets at ground level (see #5 on elevation photo for location).

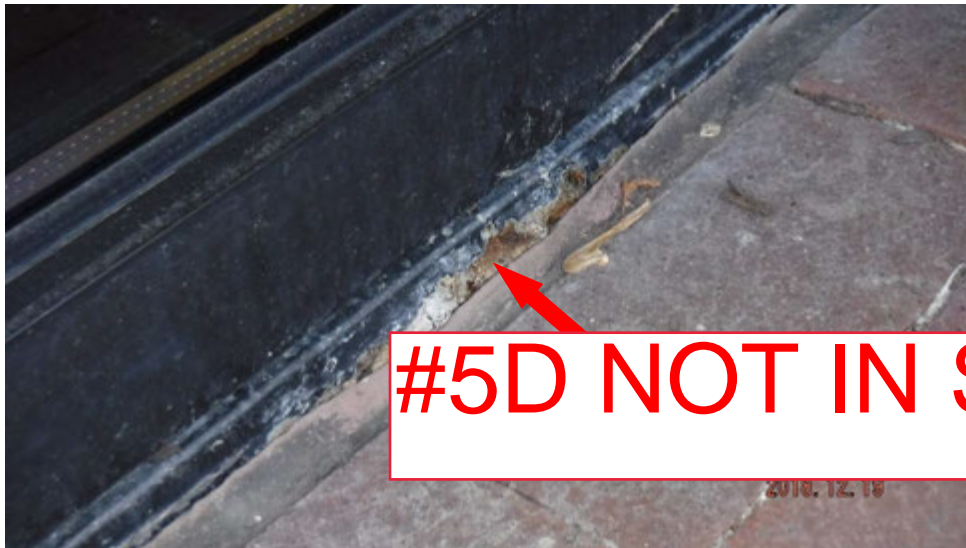
5d. Corroded steel member at base of window where it sets at ground level (see #5 on elevation photo for location).

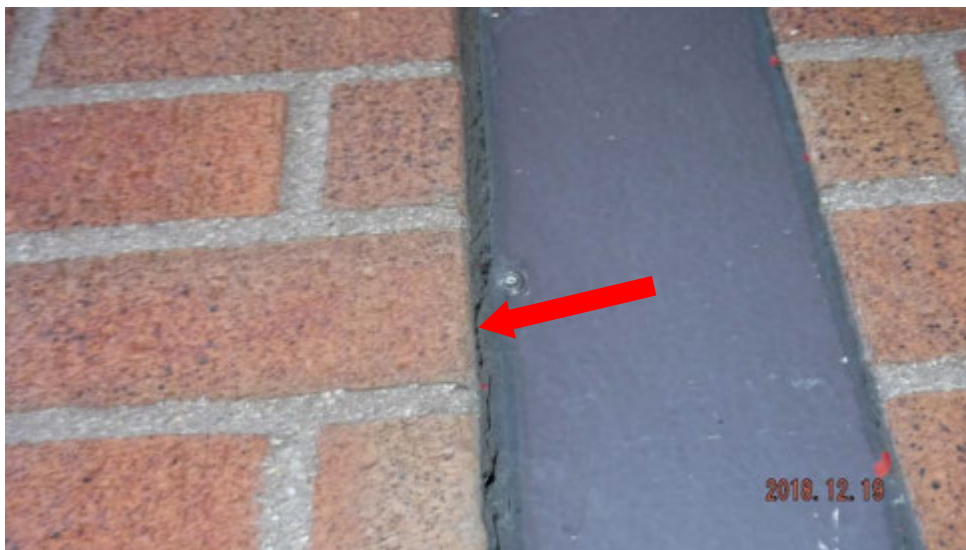
6a. Cracked/shrunk sealant joint (see #6 on elevation photo for location).

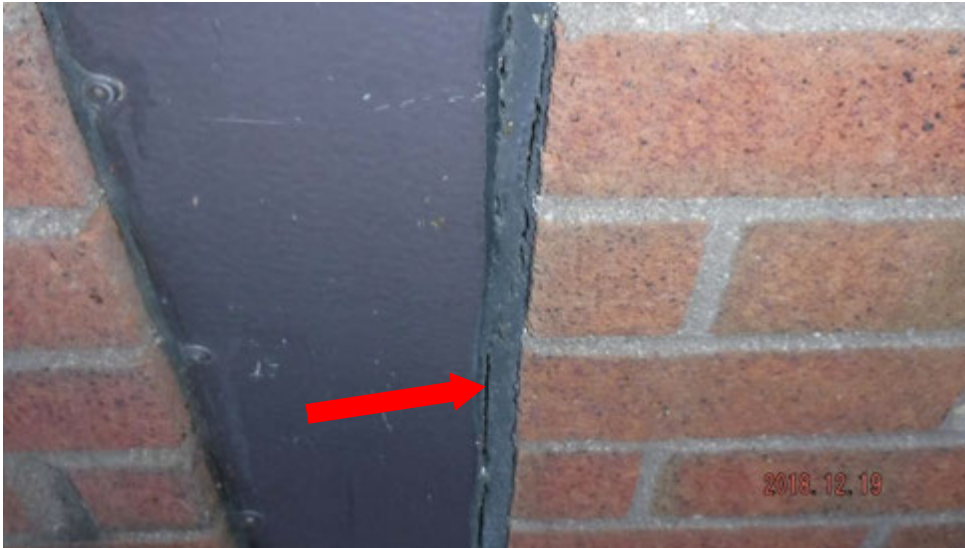
6b. Cracked/shrunk sealant joint (see #6 on elevation photo for location).

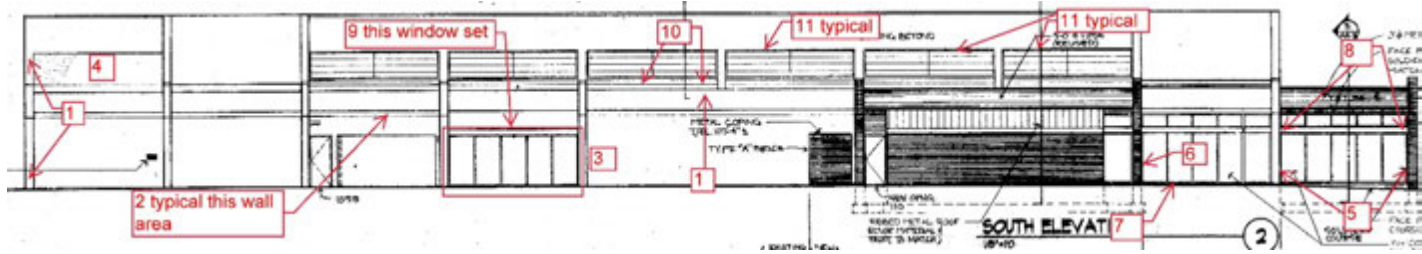
1. Finding – Masonry Brick and Mortar Joints: There are several broken bricks on the south elevation. There are also cracked/shrunk mortar joints between the bricks at various areas.

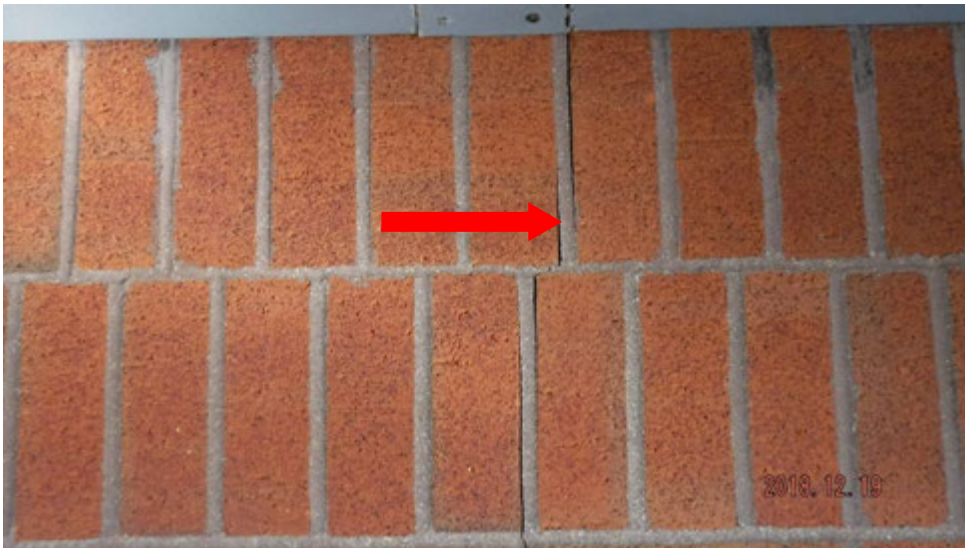
1a. Cracked/shrunk mortar joints (see #1 on elevation photo for location).

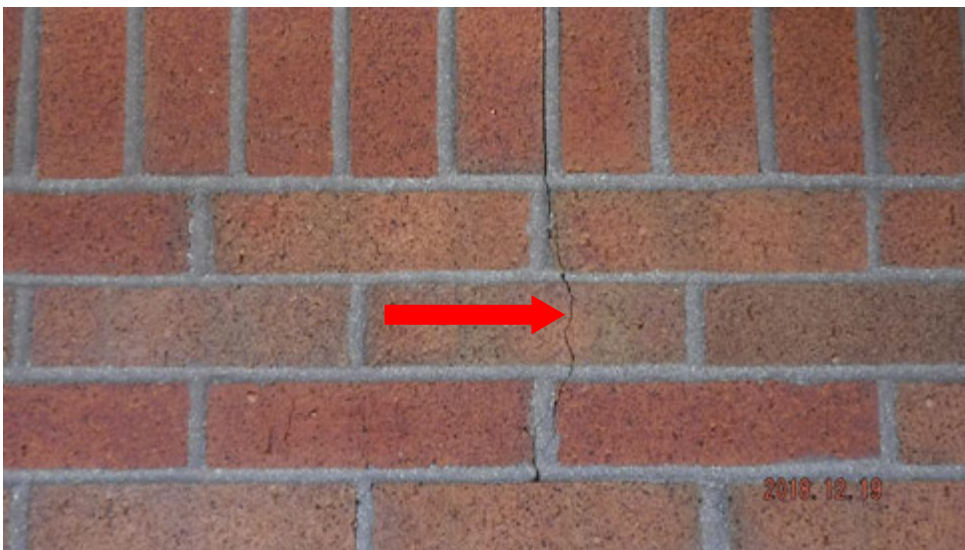
1b. Cracked/shrunk mortar joints and broken brick (see #1 on elevation photo for location).

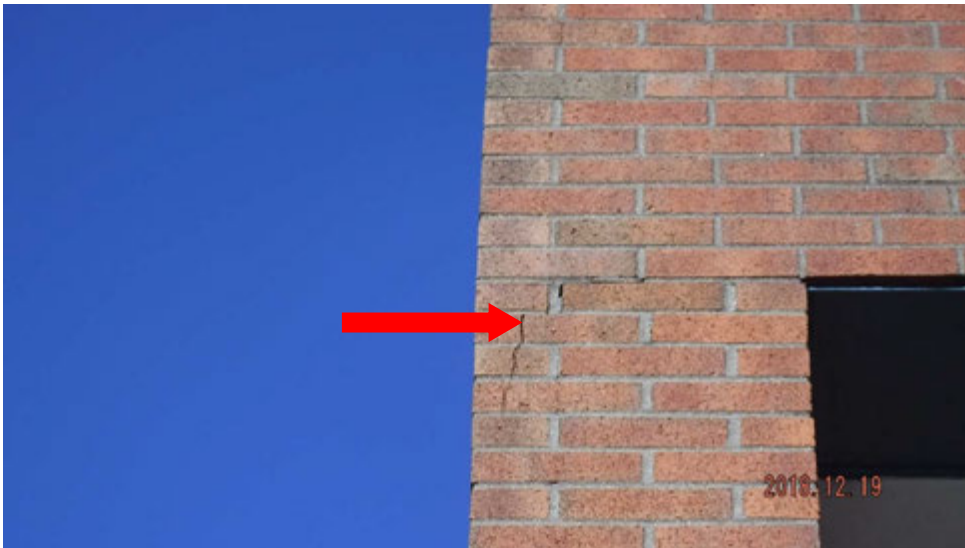
1c. Cracked/shrunk mortar joints and broken bricks (see #1 on elevation photo for location).

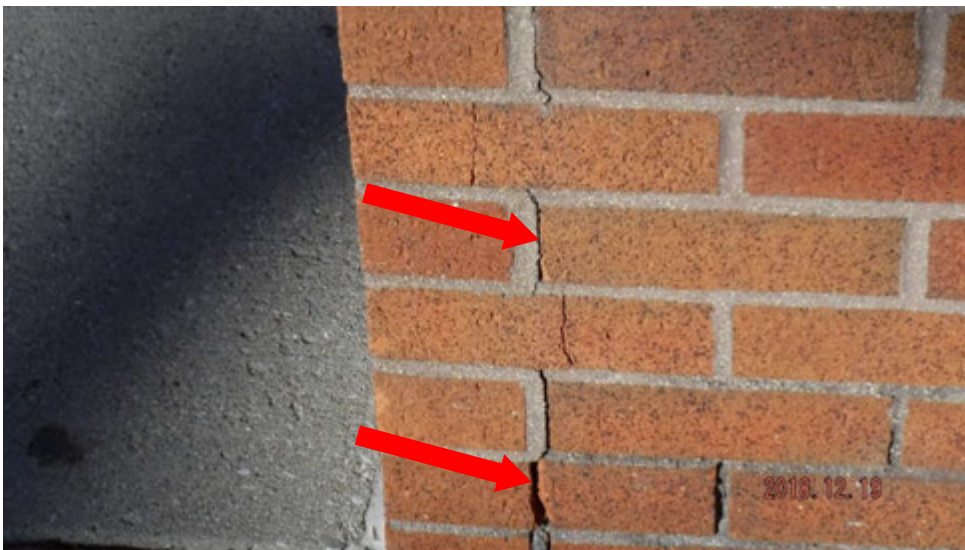
1d. Cracked/shrunk mortar joints and broken bricks (see #1 on elevation photo for location).

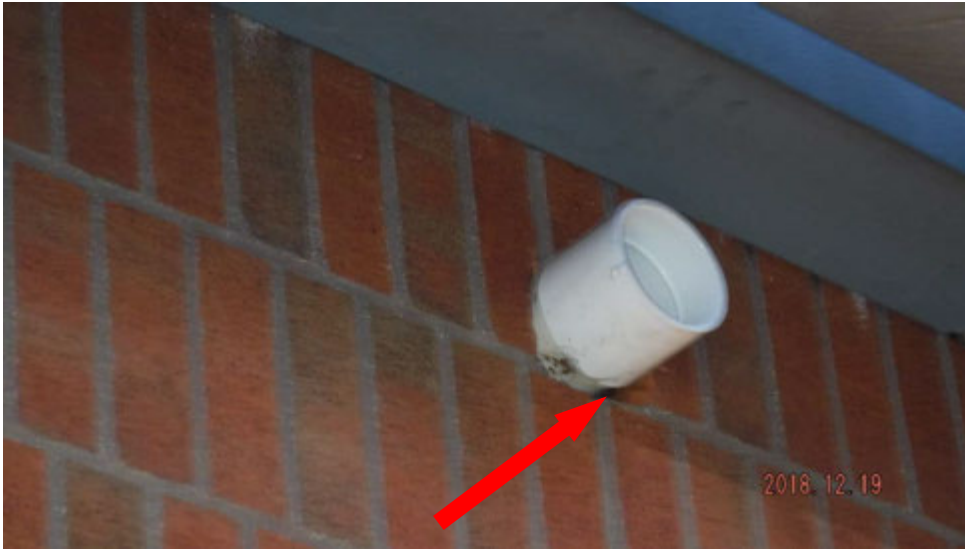
2a. Missing sealant joint (see #2 on elevation photo for typical location).

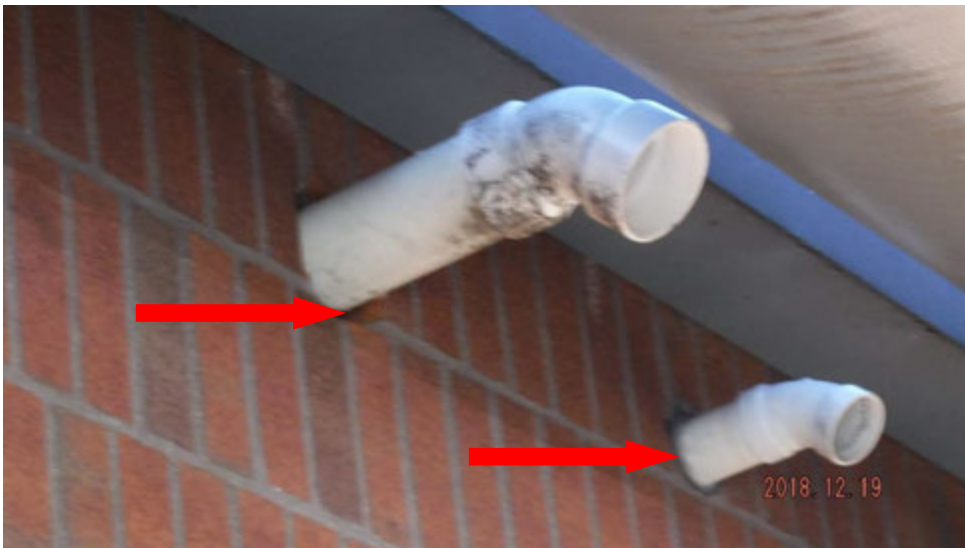
2b. Poor and/or missing sealant joints (see #2 on elevation photo for typical location).
