Mays Consulting & Evaluation Services, Inc.

A Professional Consulting & Engineering Organization

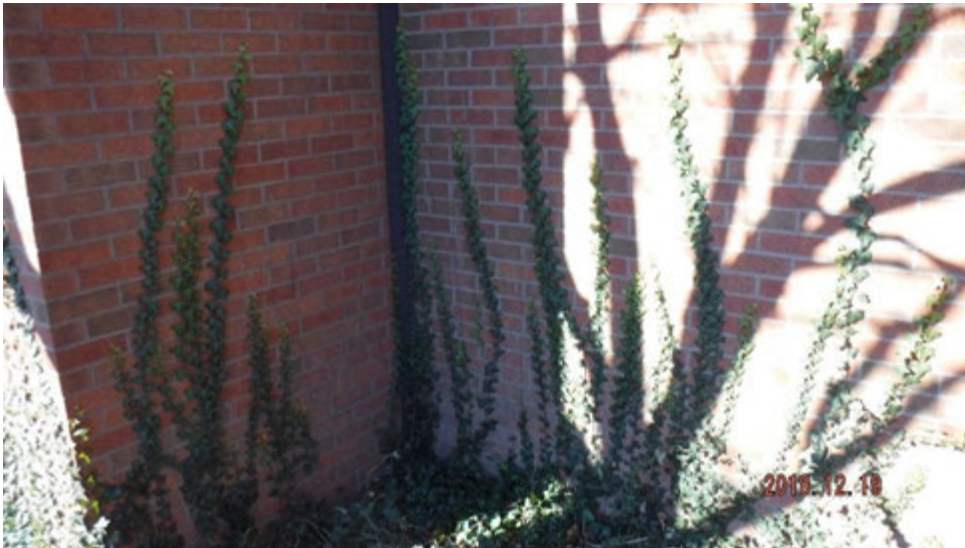
3a. Vegetation growth on walls (see #3 on elevation photo for typical location).

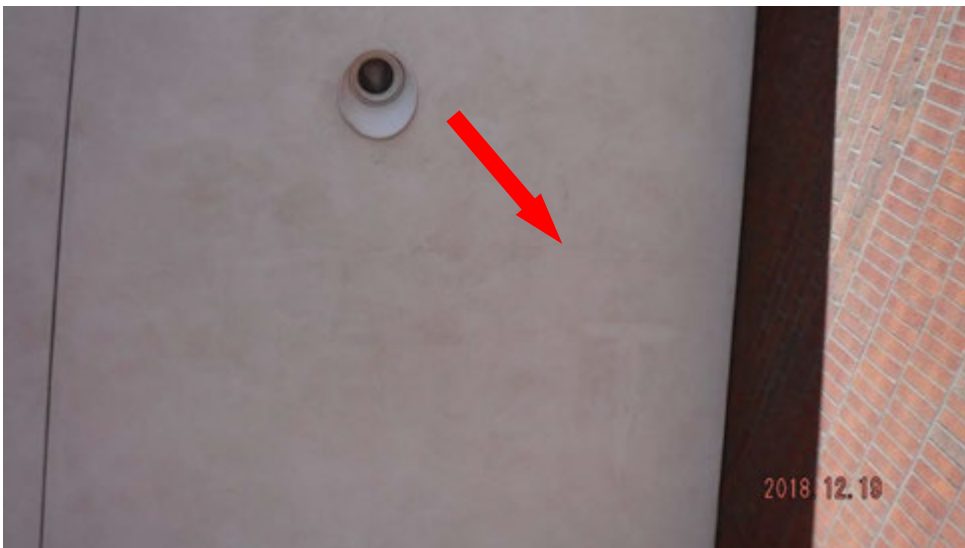
4a. Crack in plaster ceiling (see #4 on elevation photo for location). Hard to see in picture but is there.

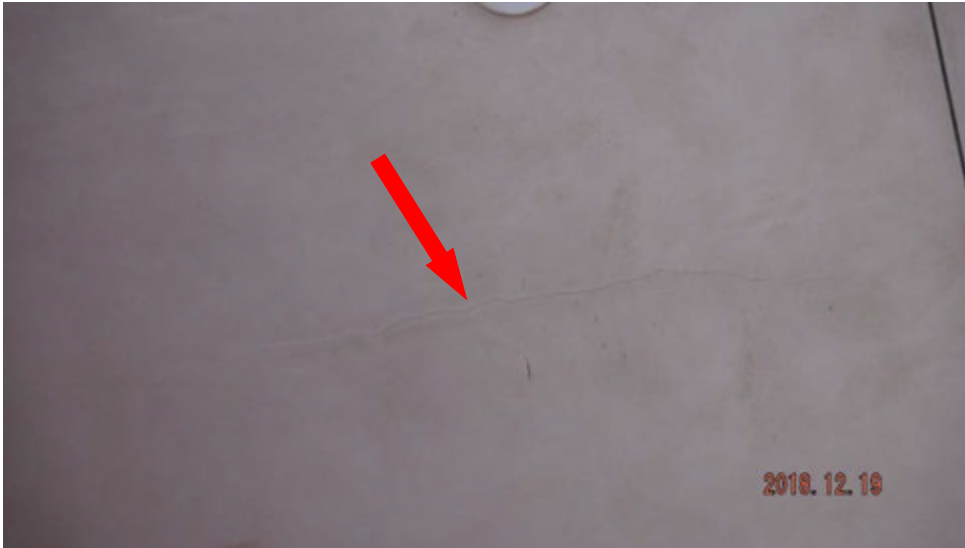
4b. Crack in plaster ceiling (see #4 on elevation photo for location).

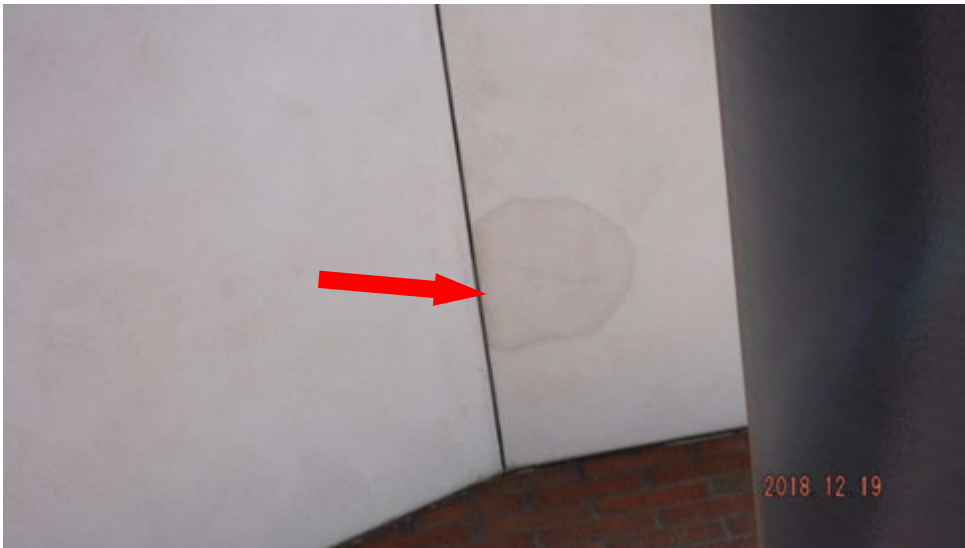
4c. Staining on plaster ceiling (see #4 on elevation photo for location).

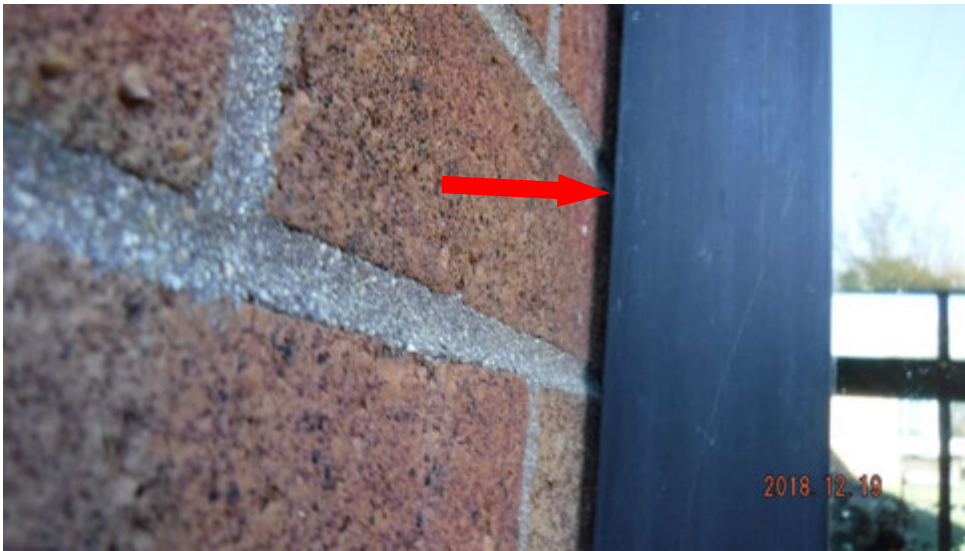
5a. Open joint between masonry wall and window frame (see #5 on elevation photo for location).

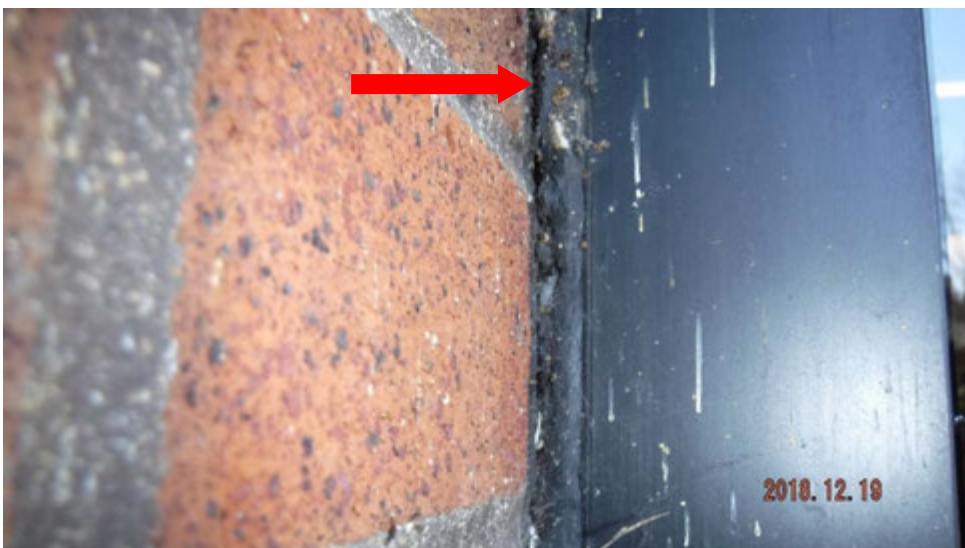
6a. Cracked/shrunk sealant joint (see #6 on elevation photo for typical locations).

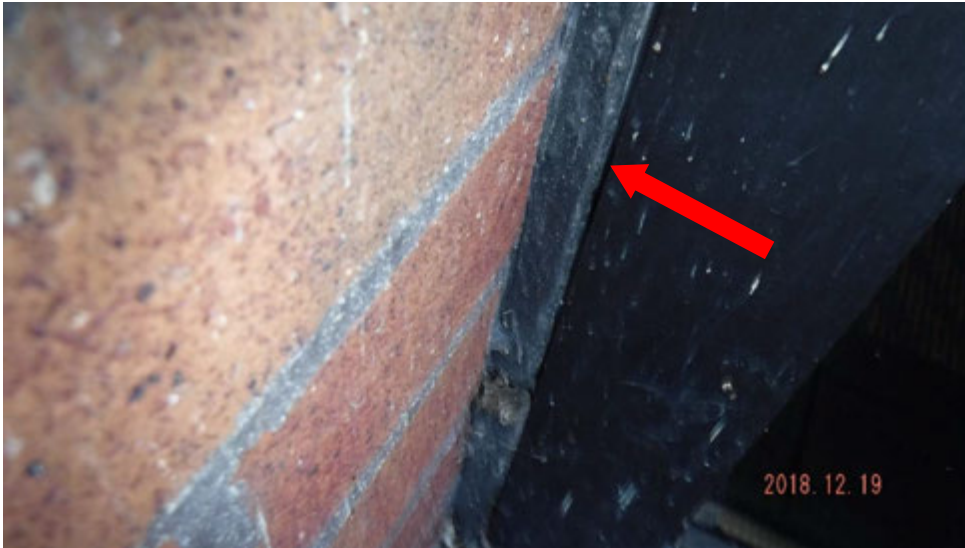
6b. Cracked/shrunk sealant joint (see #6 on elevation photo for typical locations).

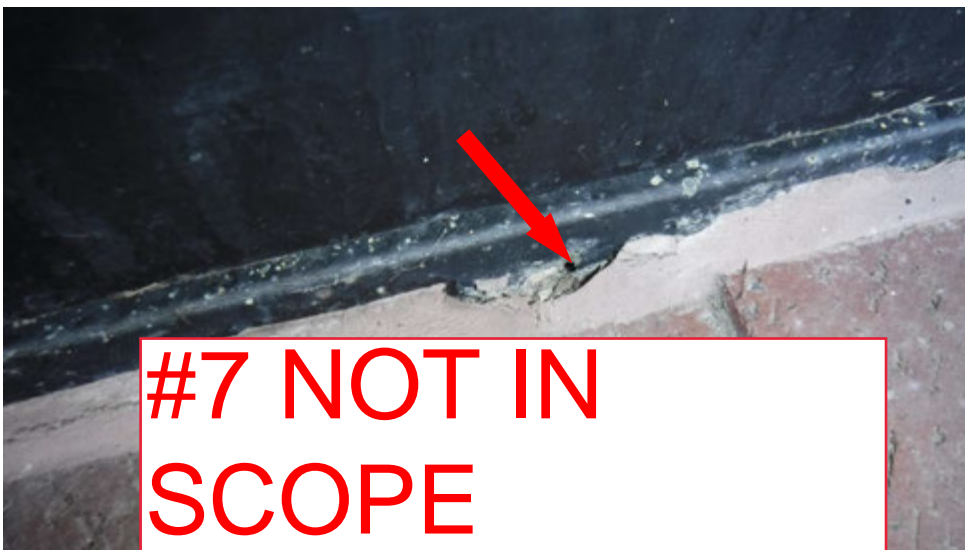
7a. Corroded steel member(s) at base of window where it sets at ground level (see #7 on elevation photo for location).

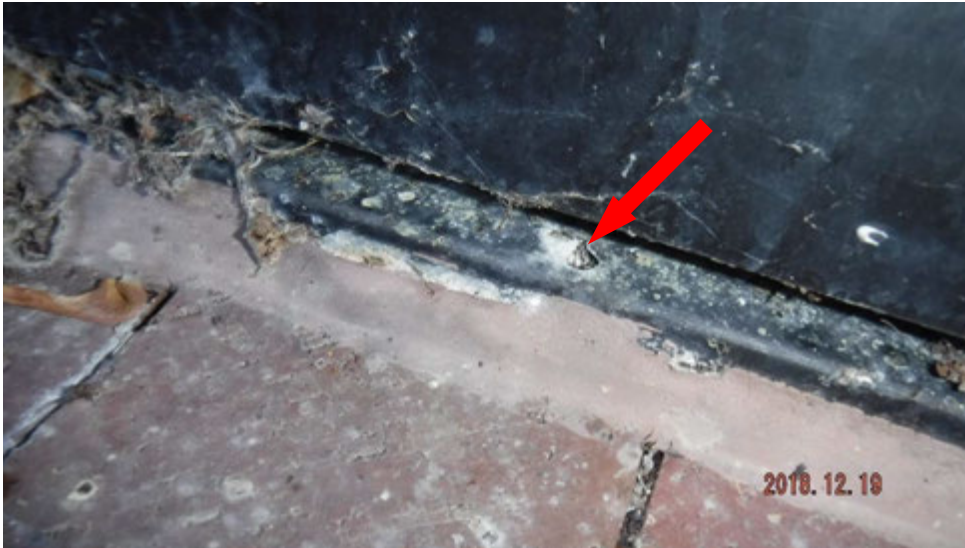
7b. Corroded steel member(s) at base of window where it sets at ground level (see #7 on elevation photo for location).

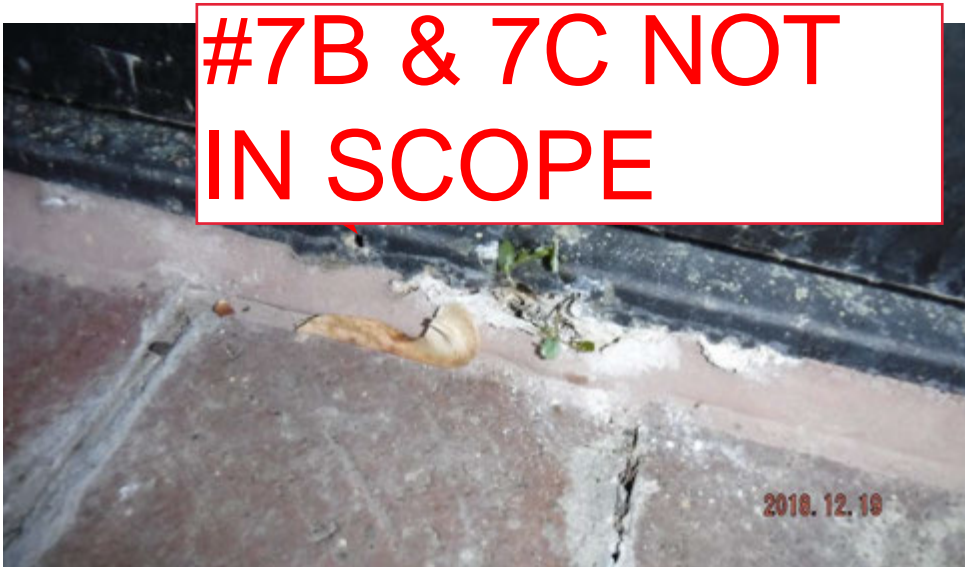
7c. Corroded steel member(s) at base of window where it sets at ground level (see #7 on elevation photo for location).

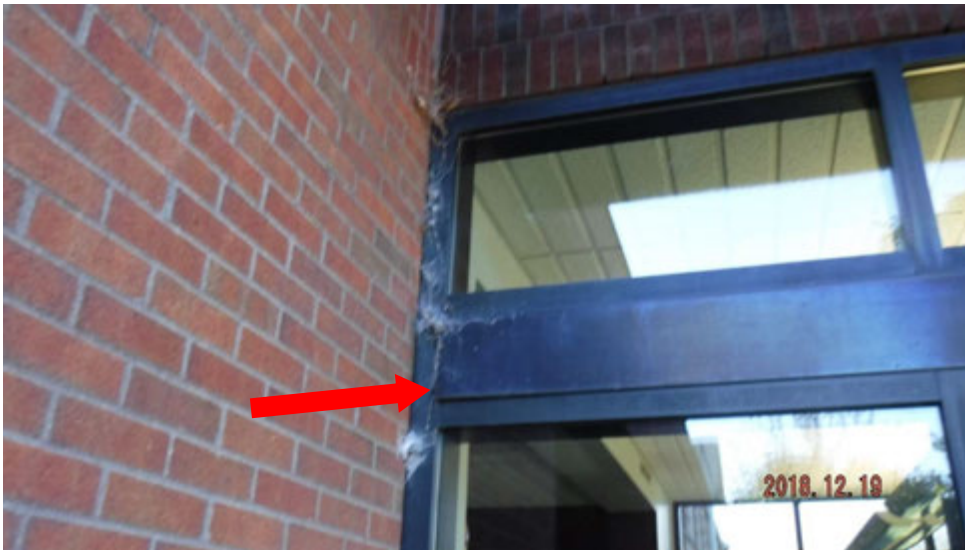
8a. Loose window trim metal between window sets (see #8 on elevation photo for location).

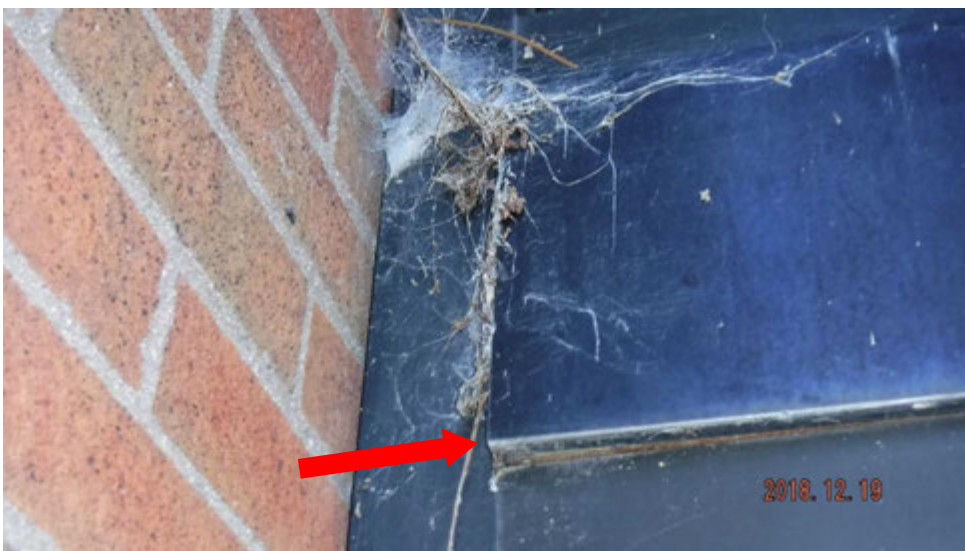
8b. Loose window trim metal between window sets. Wood could be observed behind the loose metal (see #8 on elevation photo for location).

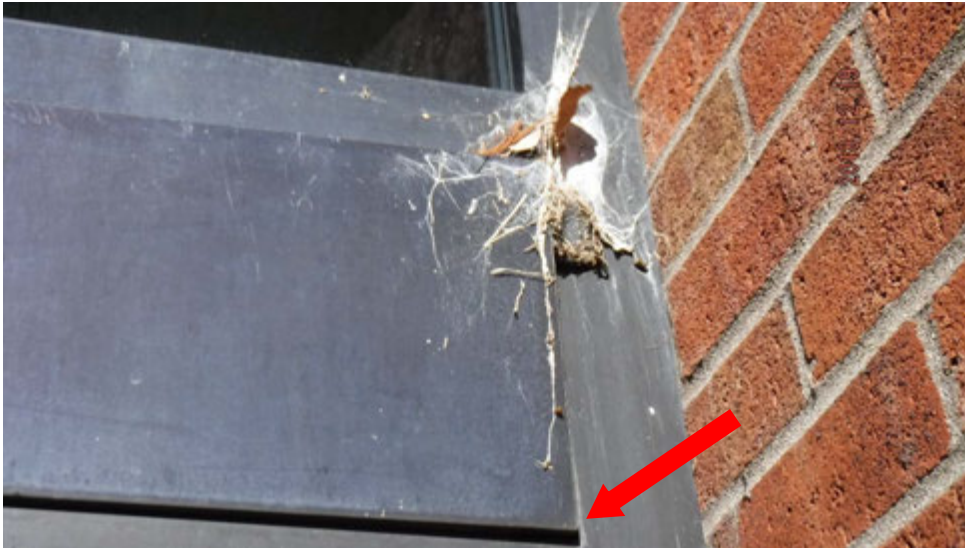
8c. Loose window trim metal between window sets. (see #8 on elevation photo for location).

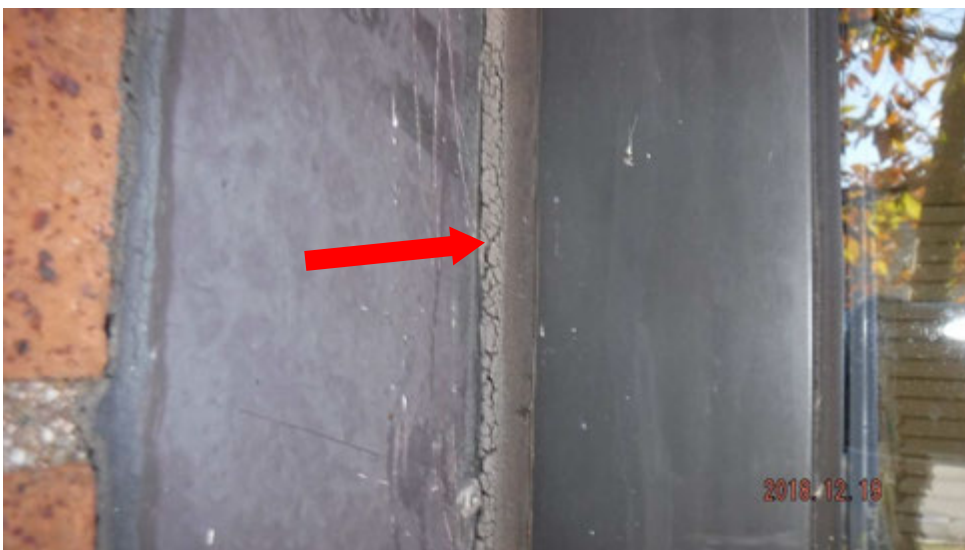
9a. Cracked/shrunk sealant joint (see #9 on elevation photo for location).

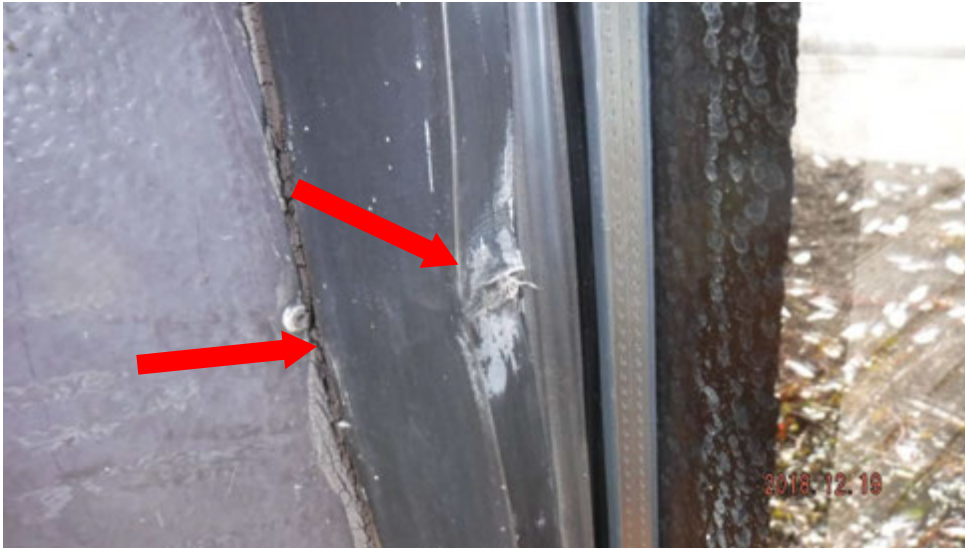
9b. Cracked/shrunk sealant joint and damage to window frame/pressure plate (see #9 on elevation photo for location).

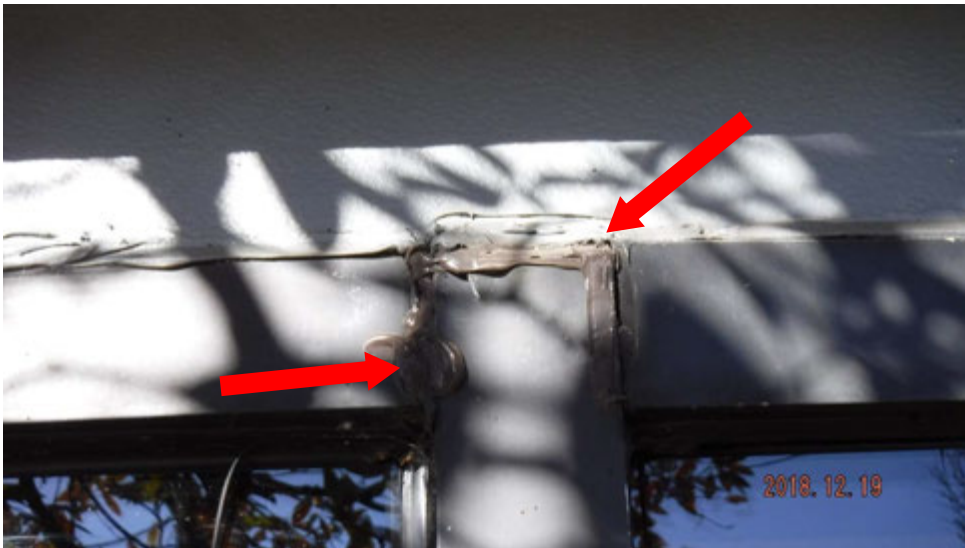
9c. Heavy top caulking over window frame/pressure plate joints (see #9 on elevation photo for location).

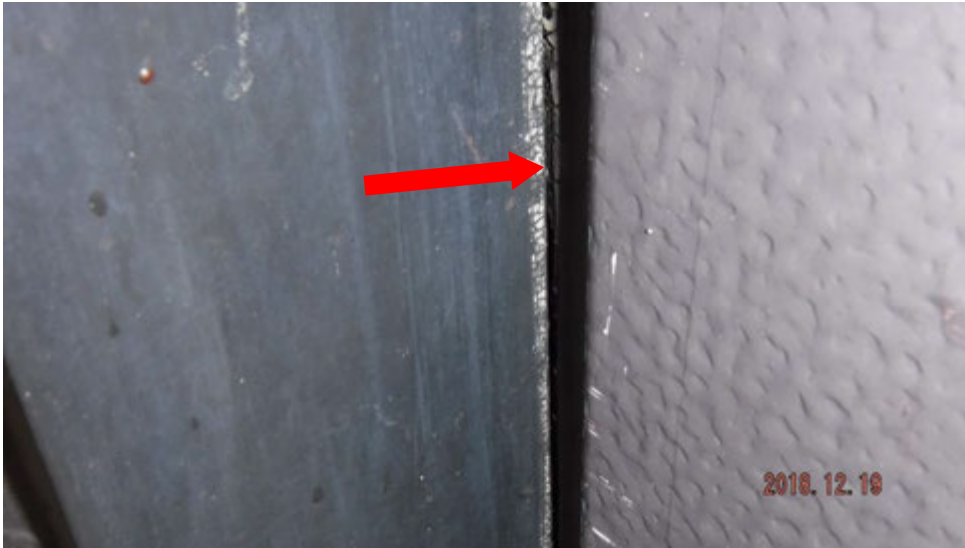
9f. Cracked/shrunk sealant joint (see #9 on elevation photo for location).

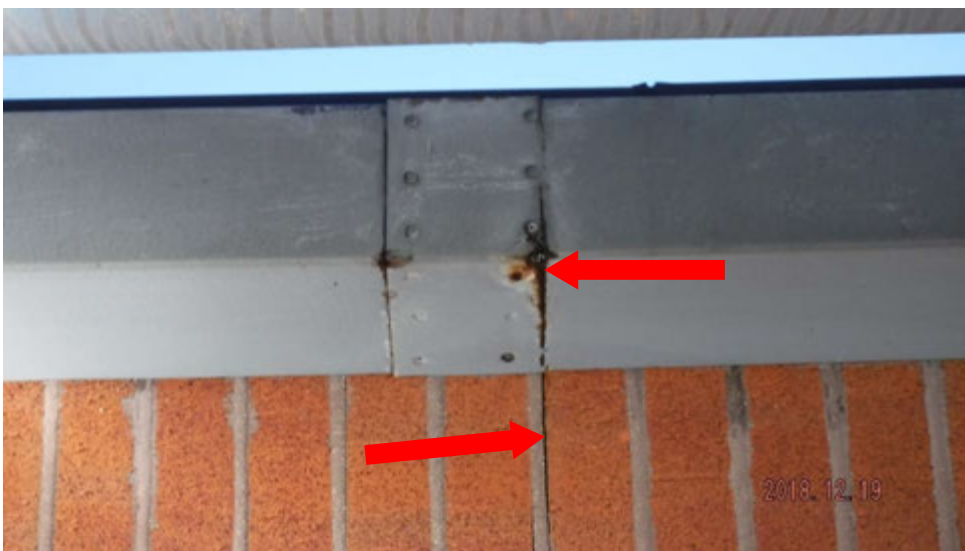
10a. Leaking gutter joint. The gutter is showing corrosion and water migrating down wall is causing masonry issues as well (see #10 on elevation photo for typical locations).

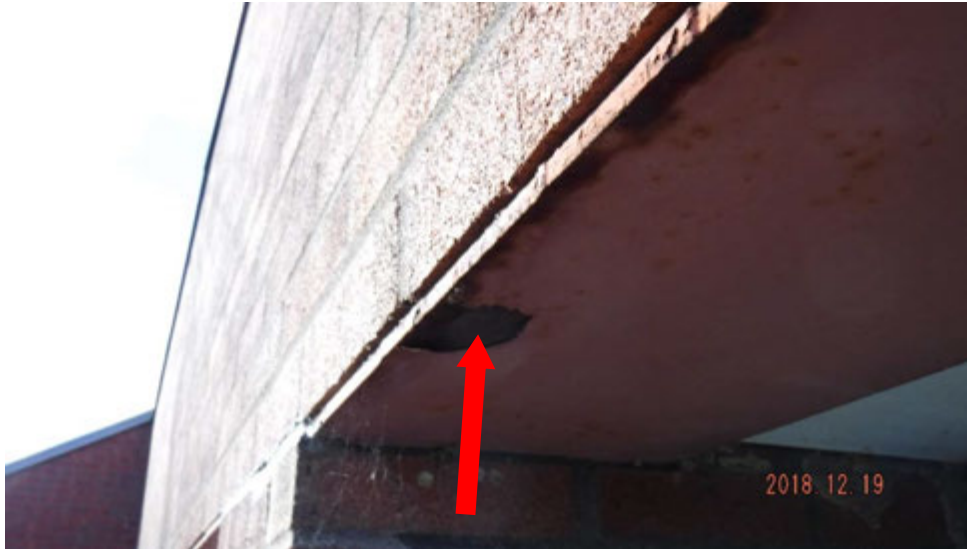
11a. Corrosion on window lintel (see #11 on elevation photo for typical locations).

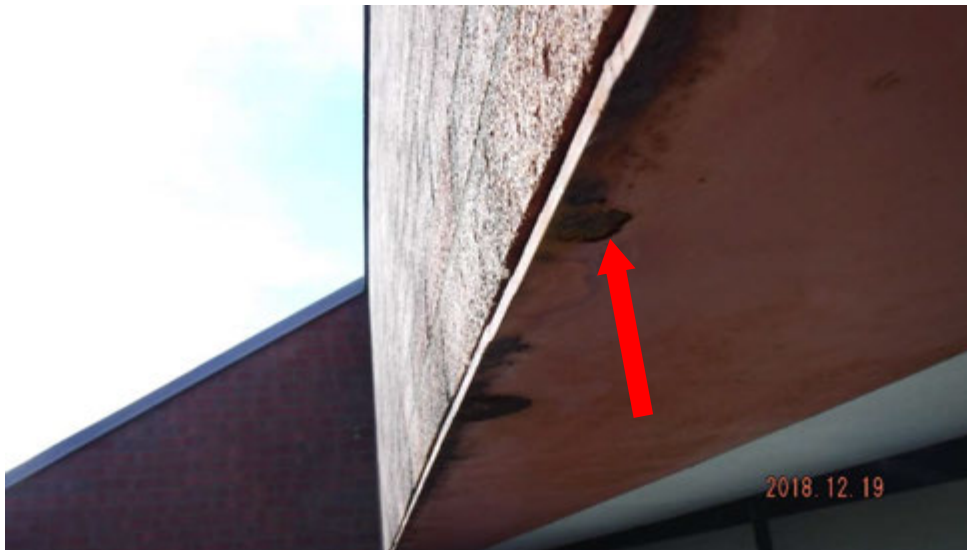
11b. Corrosion on window lintel (see #11 on elevation photo for typical locations).

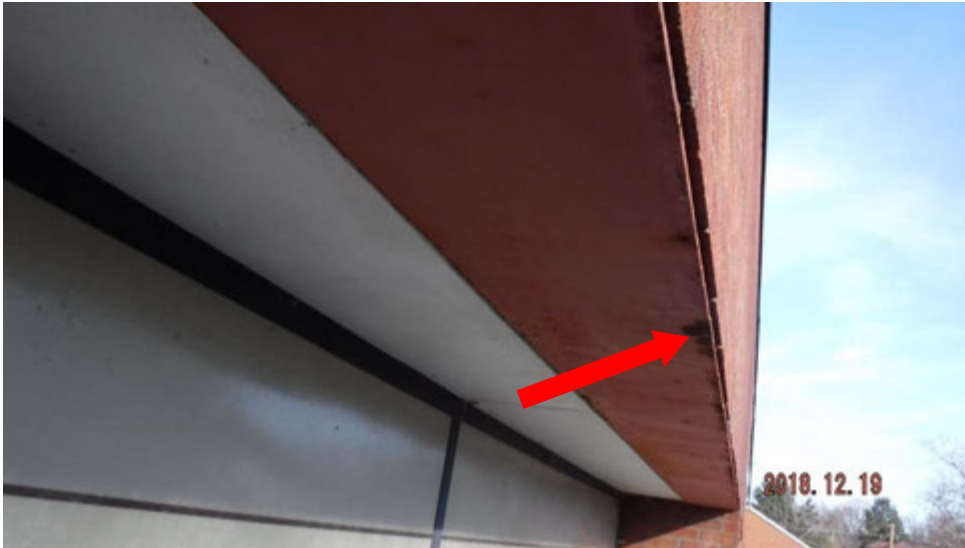
11c. Corrosion on window lintel (see #11 on elevation photo for typical locations).

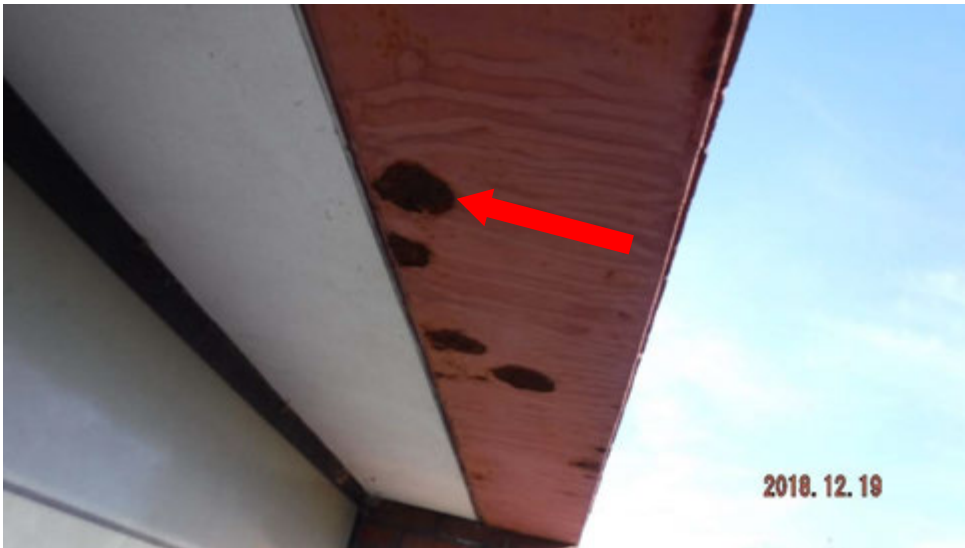
11d. Corrosion on window lintel (see #11 on elevation photo for typical locations).

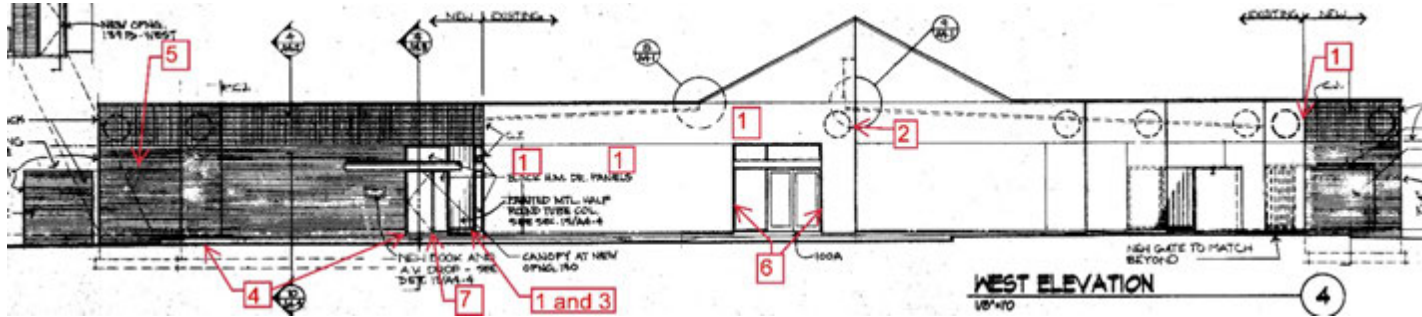
Walls Windows and Doors - West Elevation

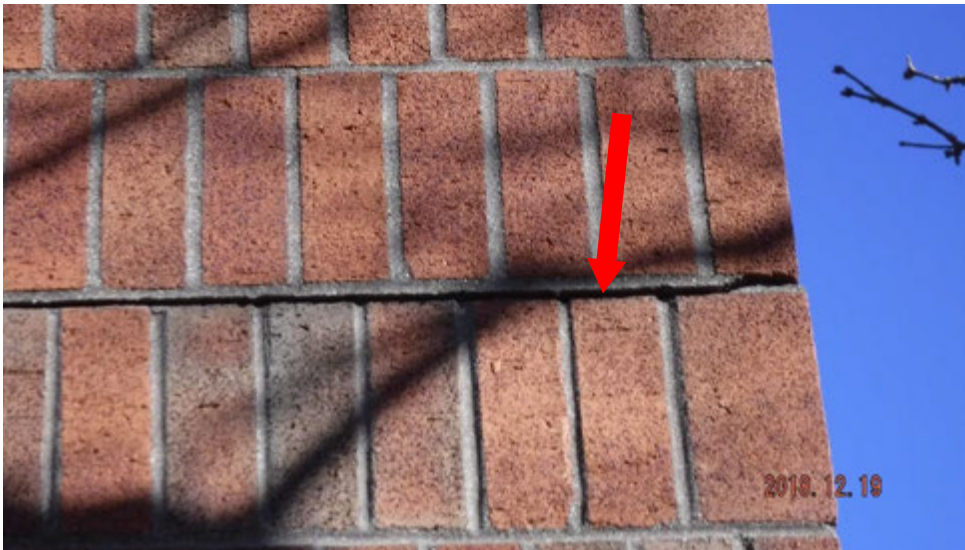
1a. Cracked/shrunk mortar joint (see #1 on elevation photo for location).

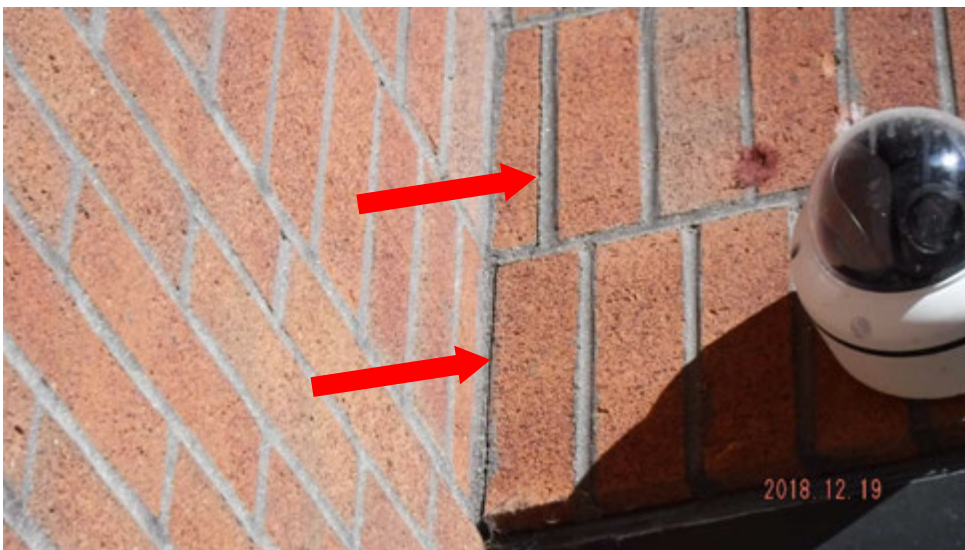
1b. Cracked/shrunk mortar joints (see #1 on elevation photo for location).

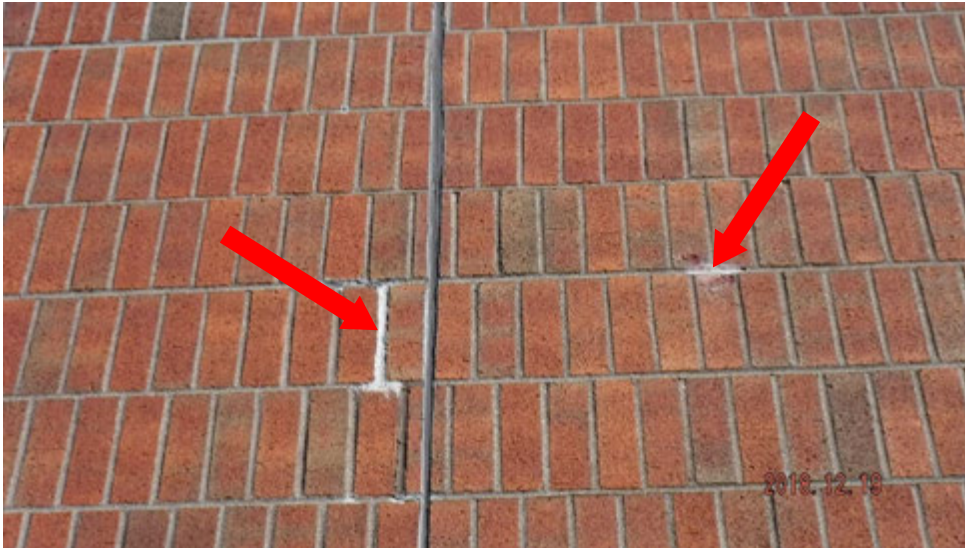
1c. Sealant repairs on mortar joints (see #1 on elevation photo for location).

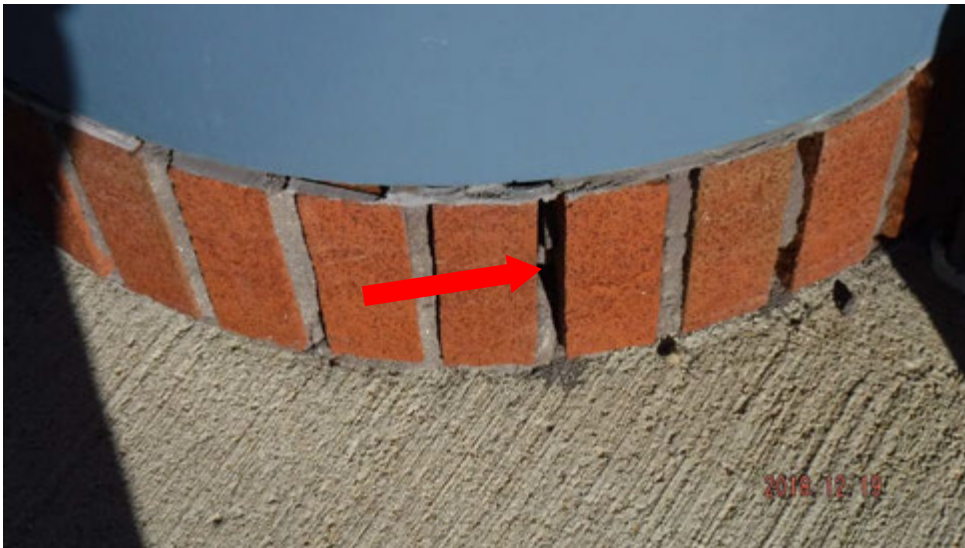
1d. Deteriorated mortar joints (see #1 on elevation photo for location).

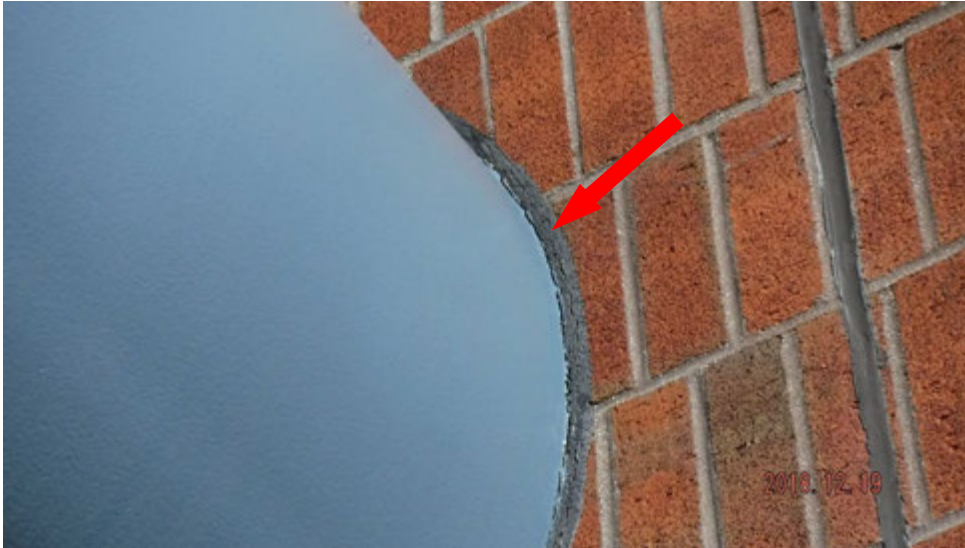
2a. Cracked/shrunk sealant joint (see #2 on elevation photo for location).

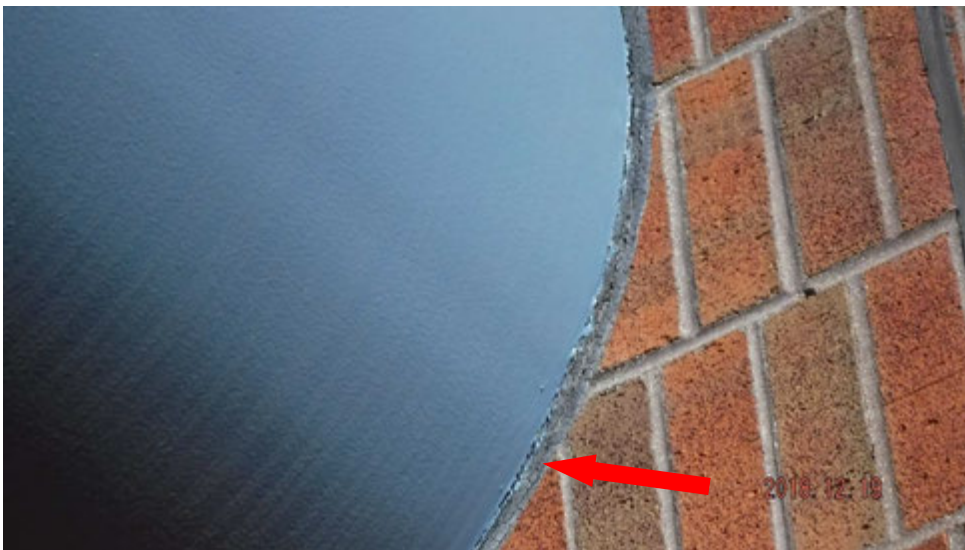
2b. Cracked/shrunk sealant joint (see #2 on elevation photo for location).

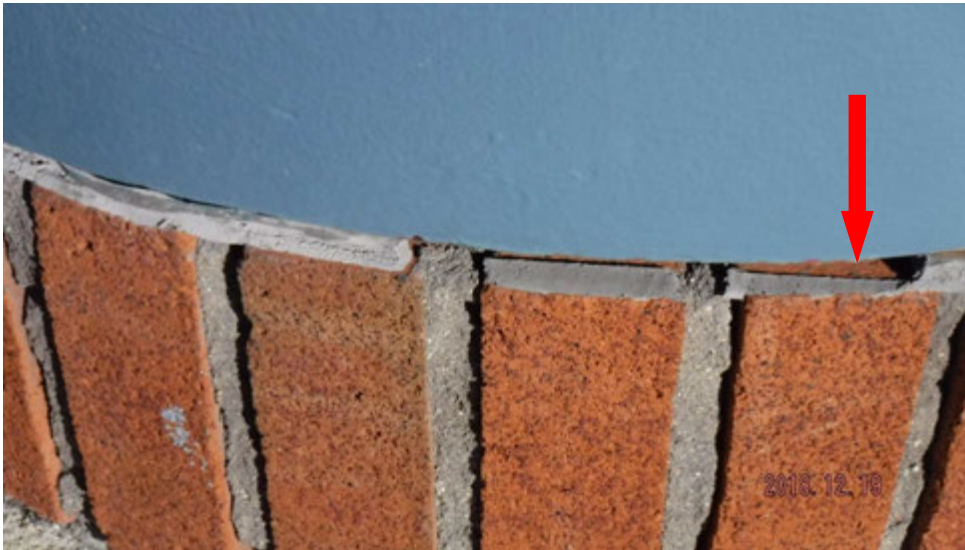
3a. Cracked/shrunk sealant joint (see #3 on elevation photo for location).

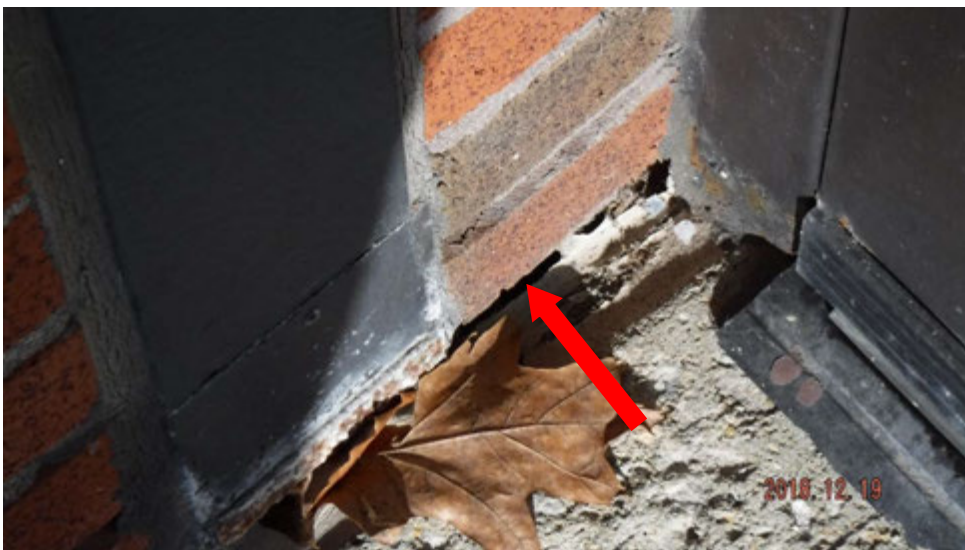
4a. Cracked/shrunk sealant joint between masonry wall and concrete sidewalk (see #4 on elevation photo for location).

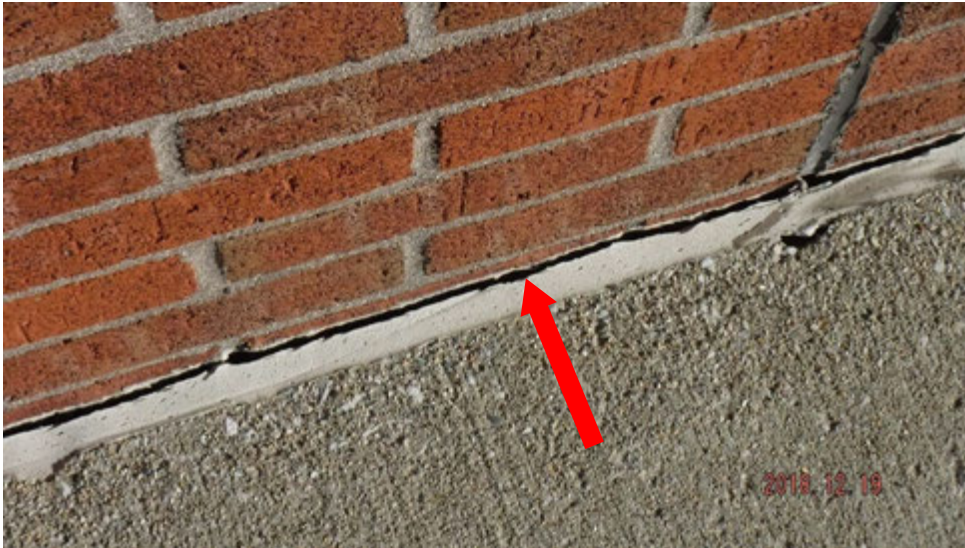
4b. Cracked/shrunken sealant joint between masonry wall and concrete sidewalk (see #4 on elevation photo for location).

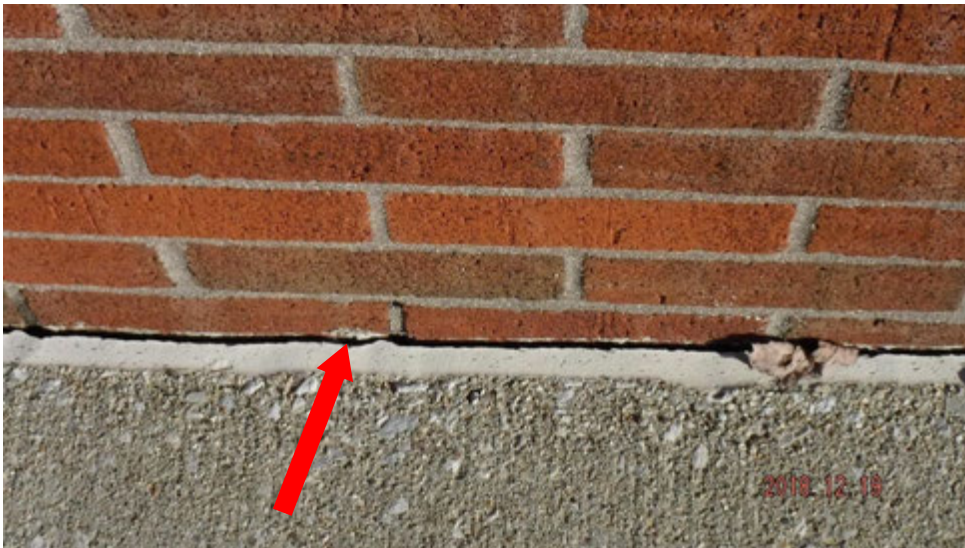
4c. Cracked/shrunken sealant joint between masonry wall and concrete sidewalk (see #4 on elevation photo for location).

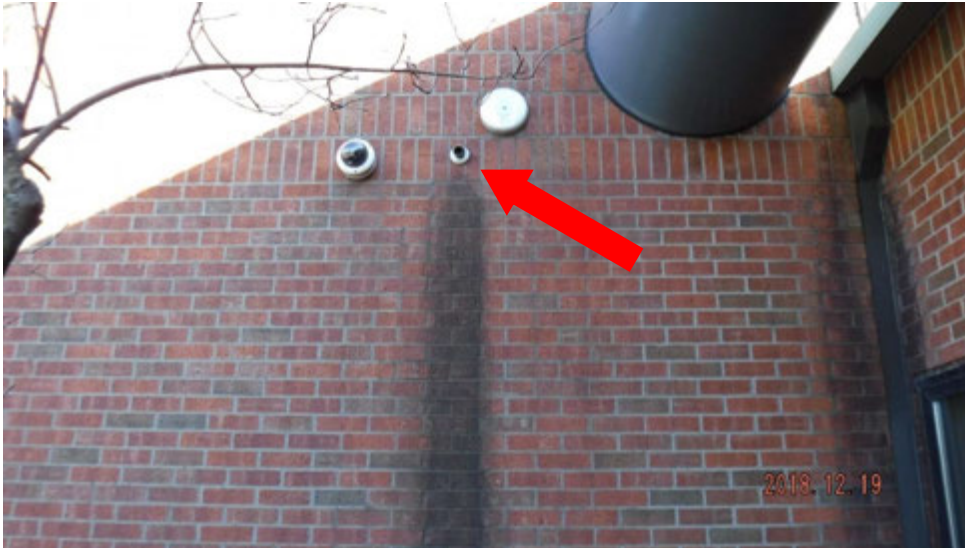
5a. Through wall pipe discharging down wall and staining the brick (see #5 on elevation photo for location).

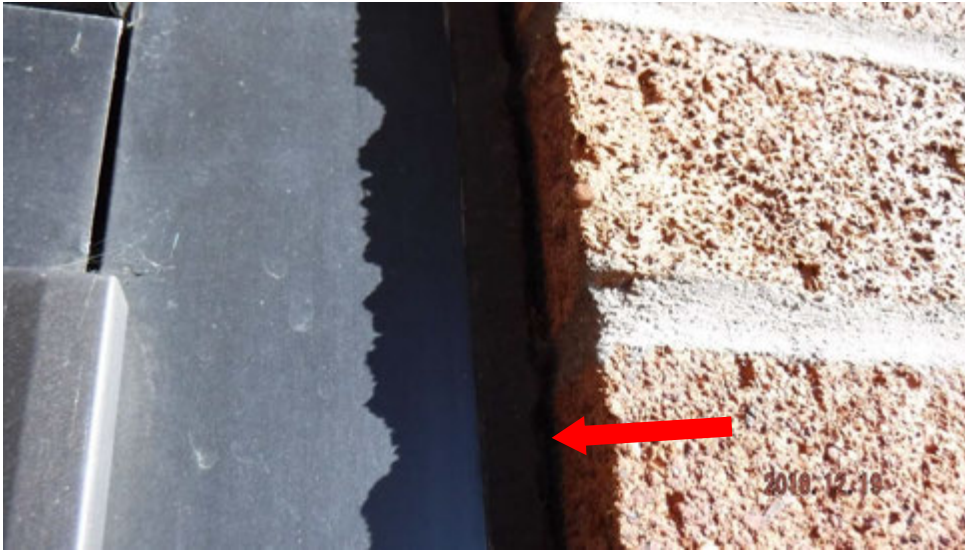
6a. Cracked/shrunk sealant joint (see #6 on elevation photo for typical locations).

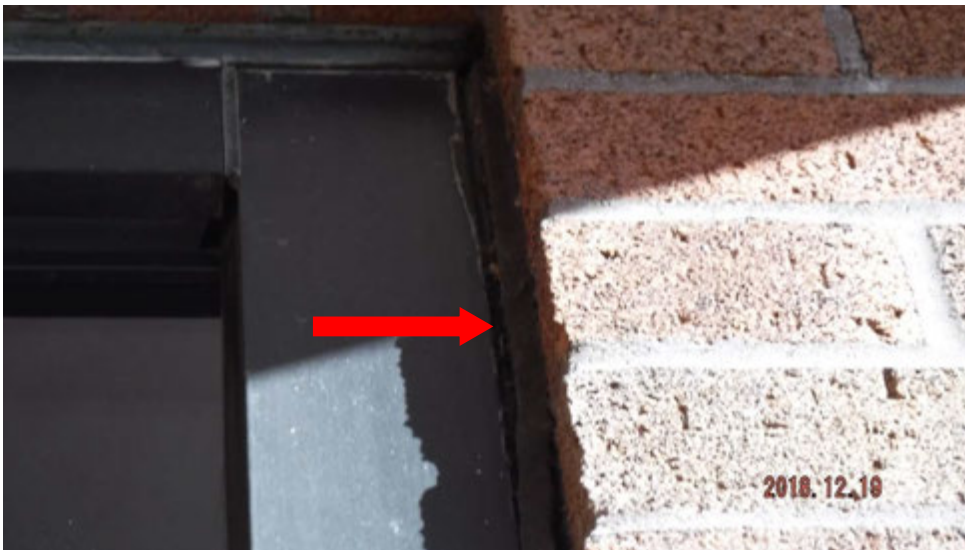
6b. Cracked/shrunk sealant joint (see #6 on elevation photo for typical locations).

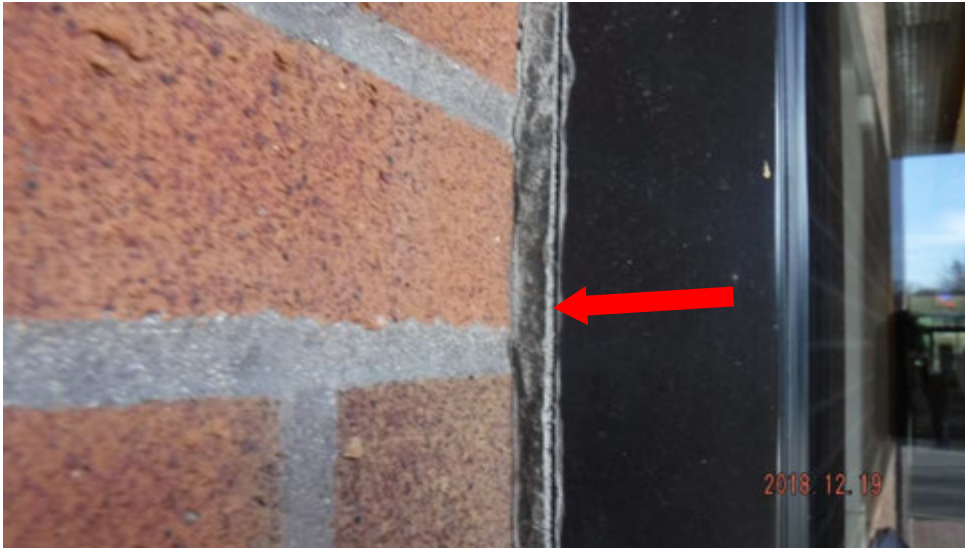
6c. Cracked/shrunken sealant joint (see #6 on elevation photo for typical locations).

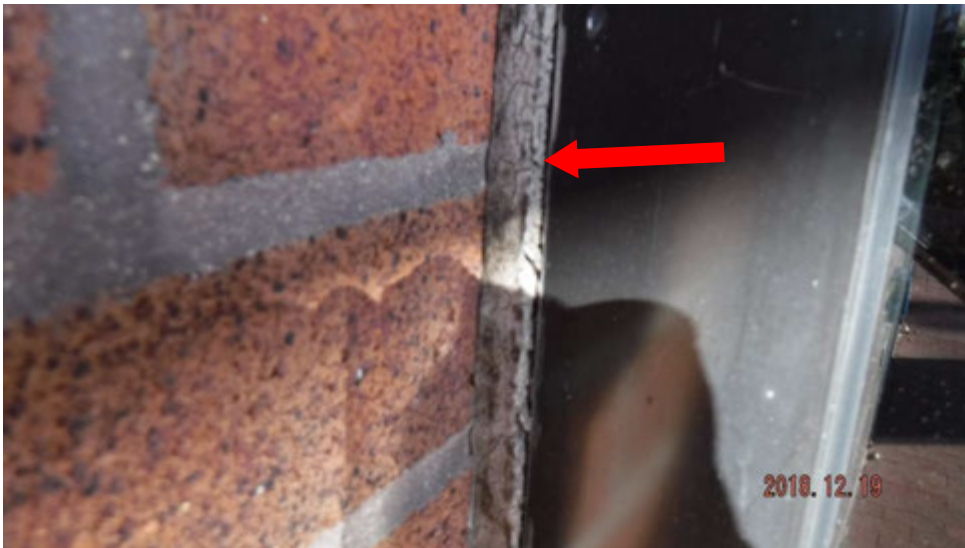
6d. Cracked/shrunken sealant joint (see #6 on elevation photo for typical locations).

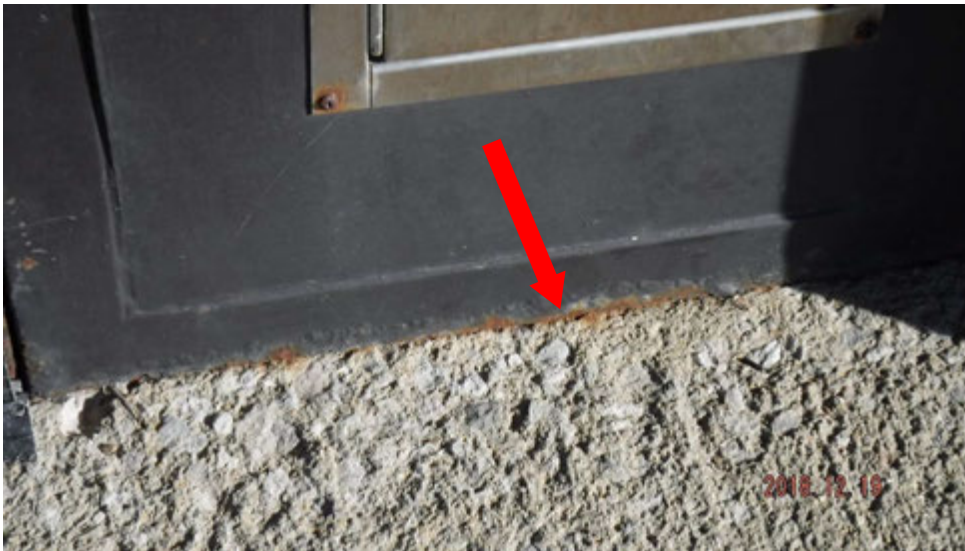
7a. Corrosion at door frame (see #7 on elevation photo for location).

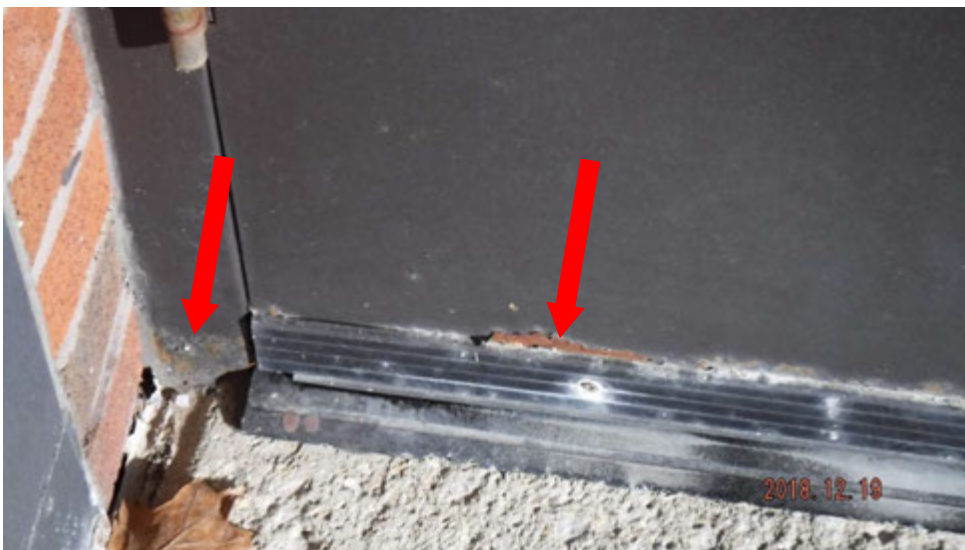
7b. Corrosion at door and door frame (see #7 on elevation photo for location).
